When is Corrosion Not Corrosion? A Decade of MFL Pipeline Inspection.

Paul Tims, TotalFinaElf Exploration Norge AS, Stavanger, Norway

Owen Wilson, Andrew Palmer and Associates, Aberdeen, UK

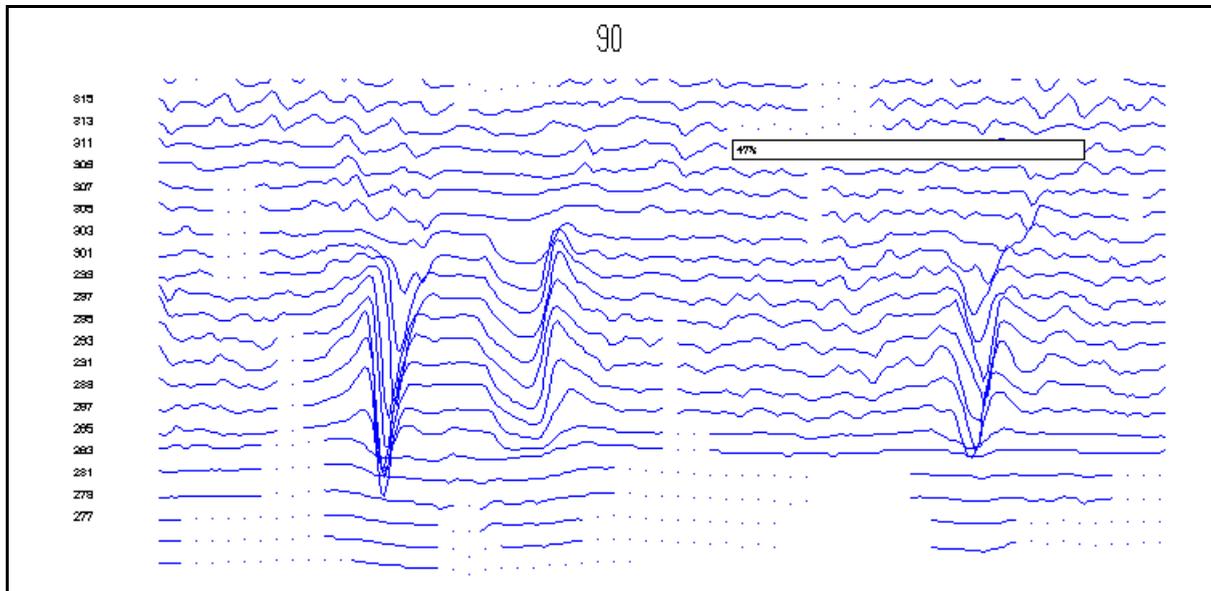
The worst defect was long and thin in shaped and situated in the 6 o'clock position. The analysis of the magnetic flux readings characterised the feature as an initially deep feature, with a step to a shallower plateau, on which further pitting corrosion was identified in the later surveys.

Figure B1 – Magnetic Flux Leakage Signal, Worst Defects, 1990

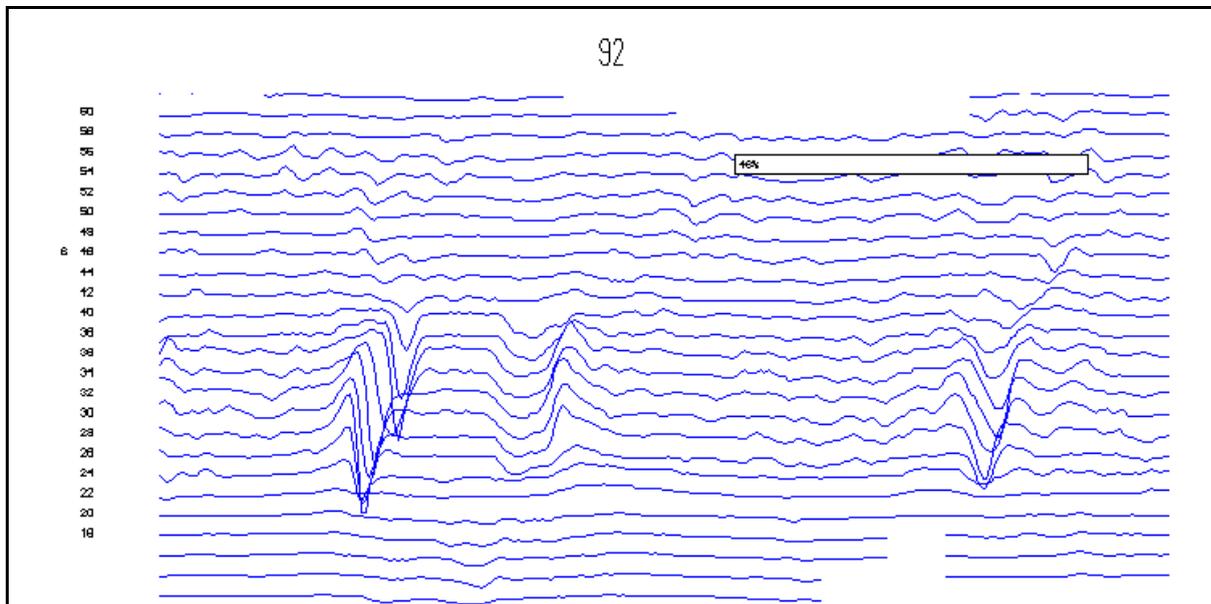
Figure B2 – Magnetic Flux Leakage Signal, Worst Defects, 1992

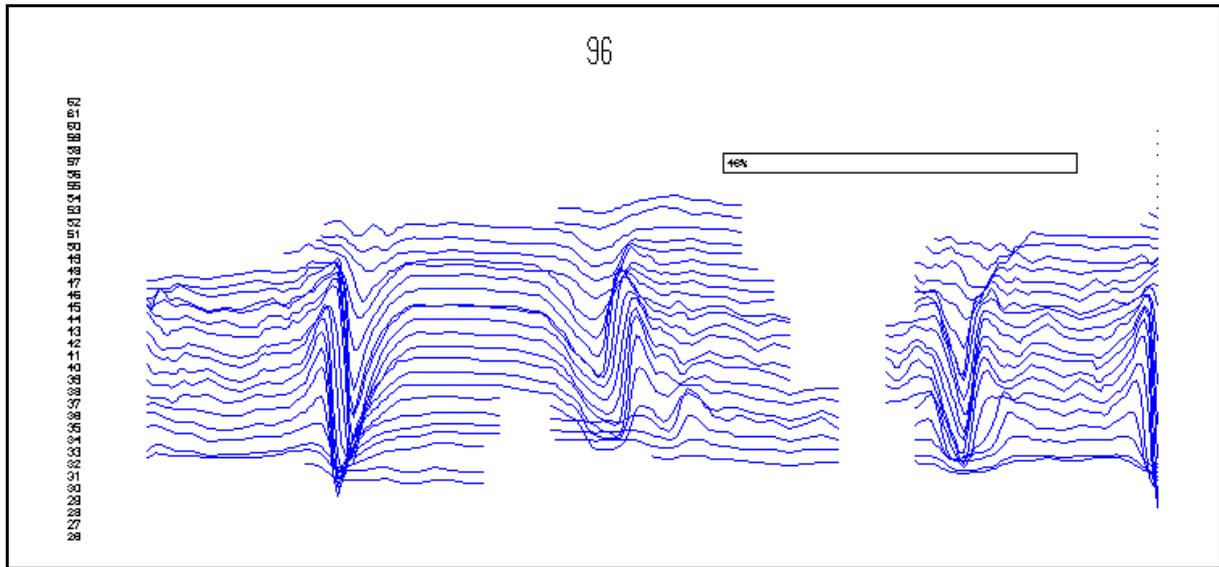
Figure B3 – Magnetic Flux Leakage Signal, Worst Defects,1996

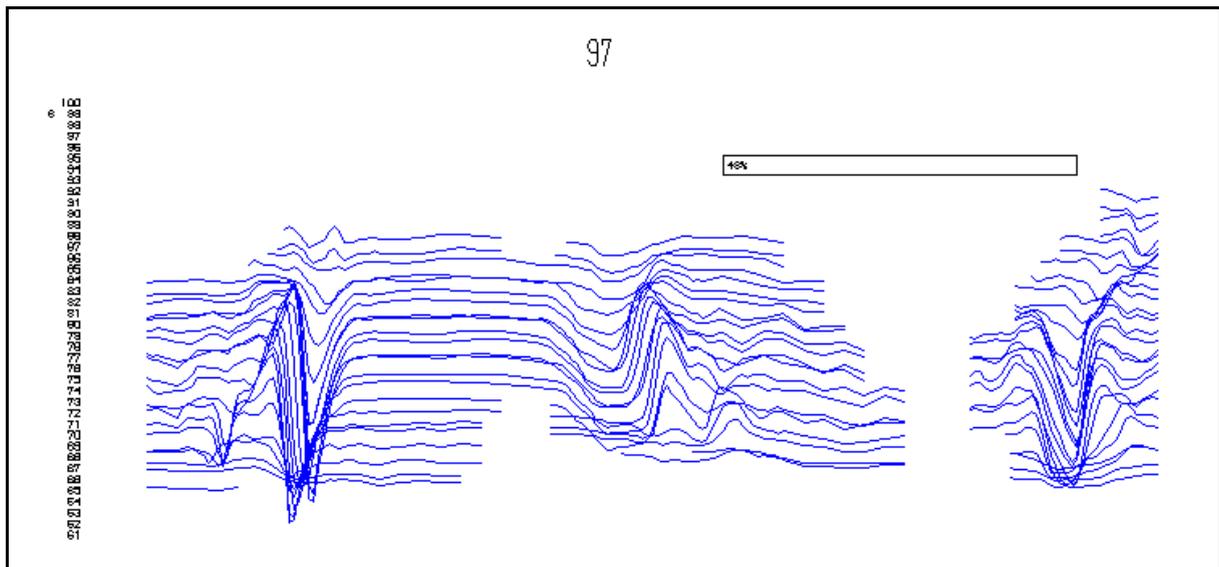
Figure B4 – Magnetic Flux Leakage Signal, Worst Defects,1997

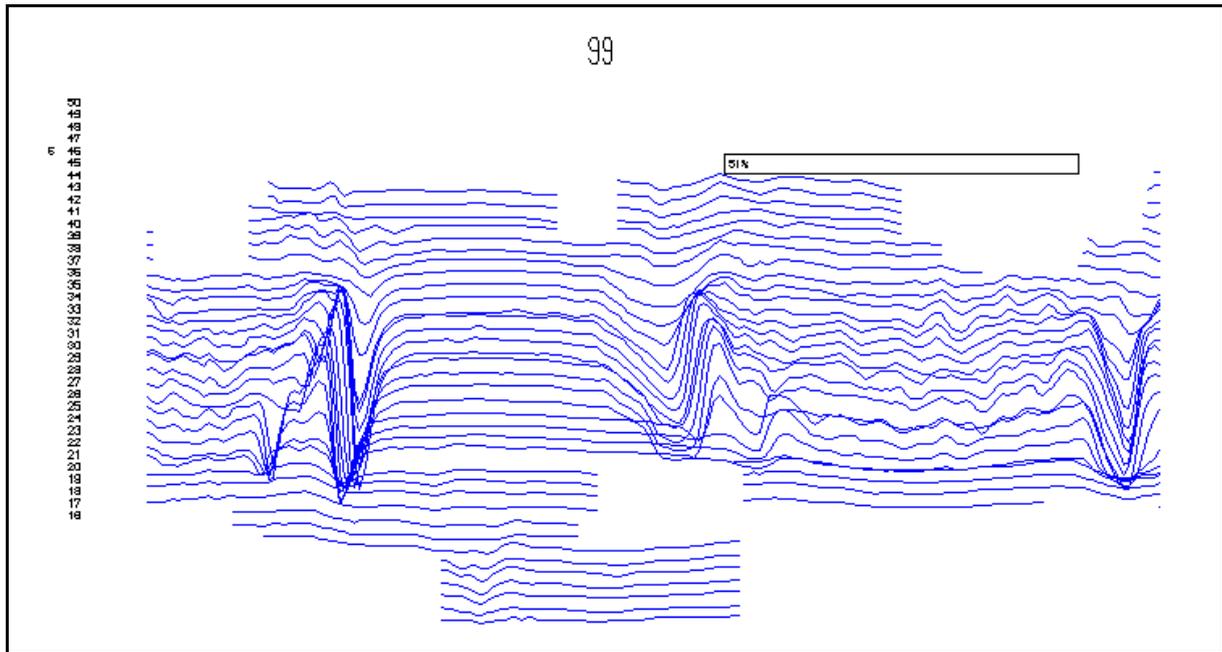
Figure B5 – Magnetic Flux Leakage Signal, Worst Defects,1999

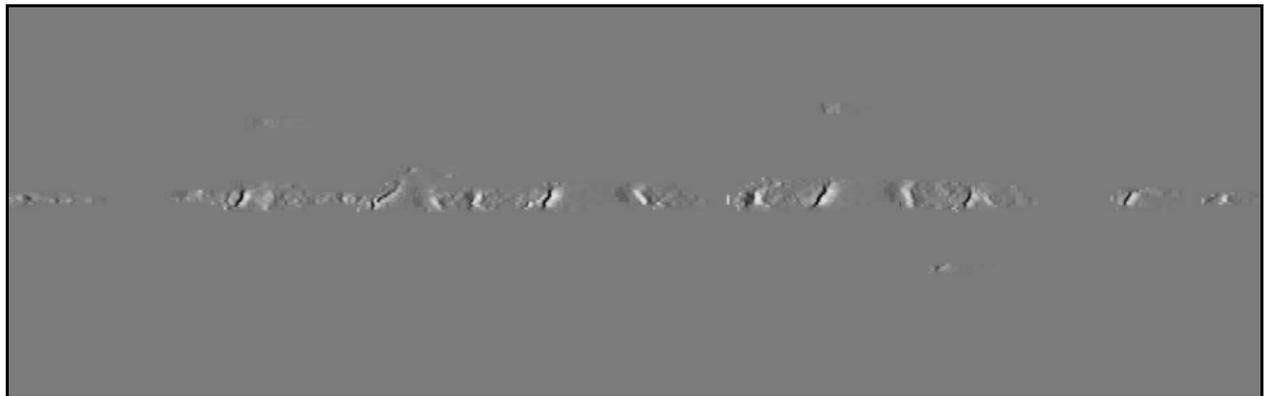
The evolution of the magnetic signal of this defect can be seen in the series of diagrams in Appendix B. Two greyscale images of the more severe features are also presented in Appendix B. The images are broadly similar, but that from the 1999 inspection clearly shows several lower level features adjacent to the main line of features. These are represented graphically in Appendix C.

Figure B6 – Greyscale MFL Signal, Worst Defects,1997

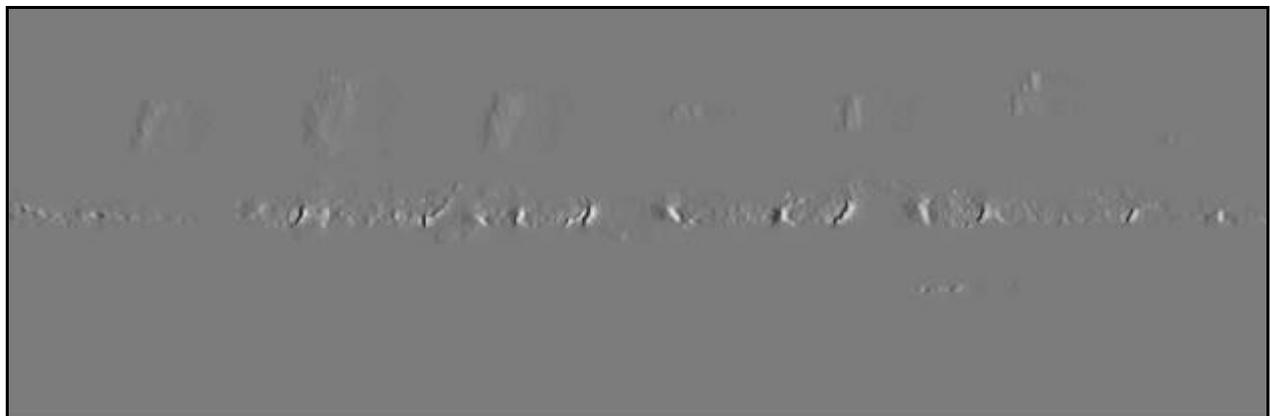
Figure B7 – Greyscale MFL Signal, Worst Defects,1999

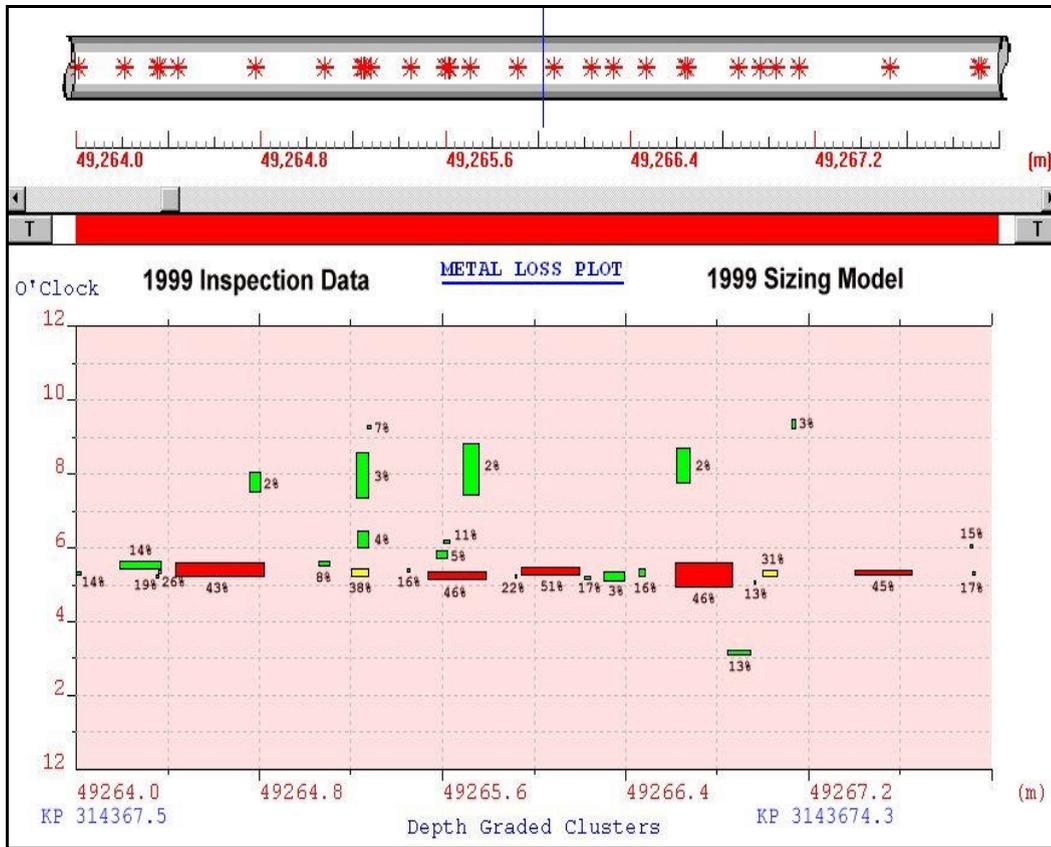
After much discussion with the inspection contractor it was discovered that the analytical process for interpreting the magnetic flux measurements from the sensor had, in fact, been upgraded in the time between the two surveys as this was felt to give a more accurate interpretation of the measurements. The question of whether the feature had physically deepened therefore remained.

Figure C1 – 1999 Inspection Data, Assessed Using 1999 Sizing Model

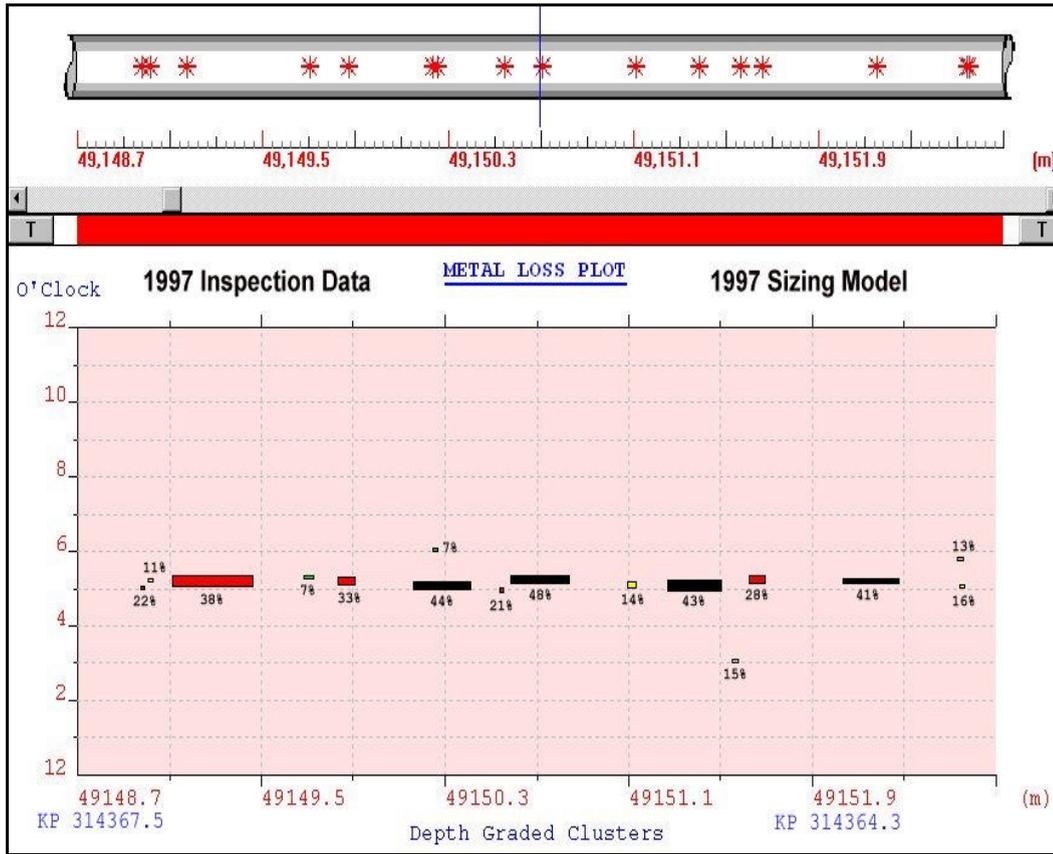
Figure C2 – 1997 Inspection Data, Assessed Using 1997 Sizing Model

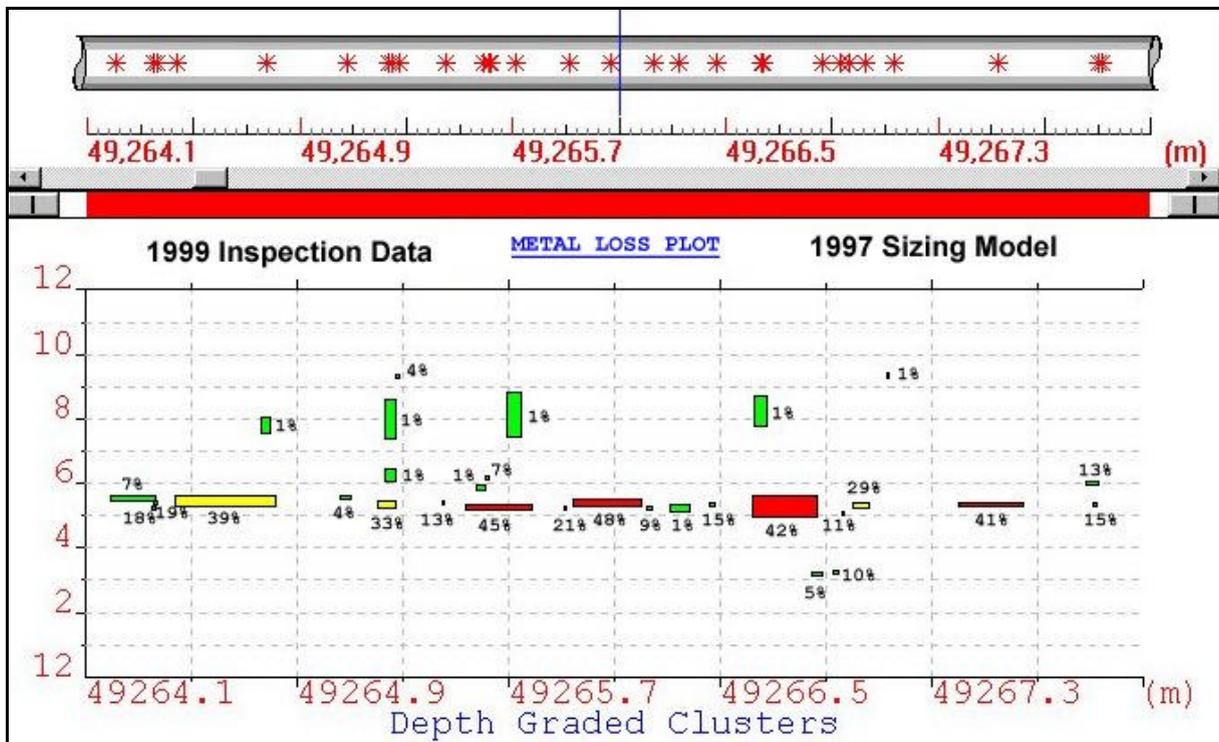
To answer this question, the 1999 results were re-interpreted with the 1997 analytical model, and the results reported the same defect depth as was previously reported with the 1997 data (as shown in Tables 1 and 2 of Appendix A). This gave confidence that the feature had not grown. Given, however, that the 1999 analytical process was considered more accurate than the 1997 model, the decision was made to re-analyse the fitness-for-purpose of the reported defects using the 1999 feature dimensions. This resulted in the down-rating of the pipeline by a further 5 bar to 123 barg. The results from 1997 and 1999 for the worst defects, and the re-interpreted results from 1999 are shown in Appendix C.

Figure C3 – 1999 Inspection Data, Re-assessed Using 1997 Sizing Model

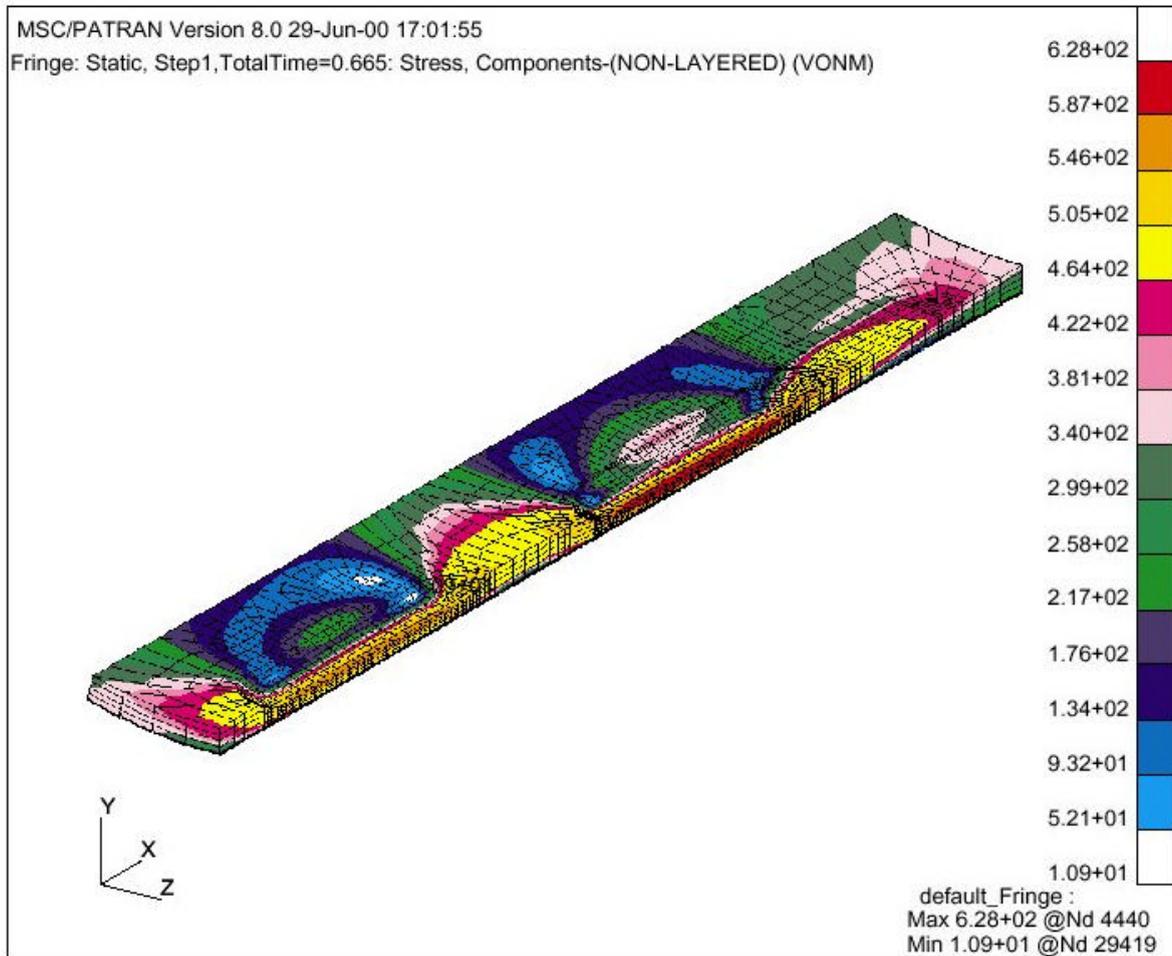
The FEA study considered five combinations of potentially interacting defects contained in the worst affected pipe joint. The study also investigated the effects of the inspection tool measurement tolerances on the predicted defect failure pressures. The analyses determined the predicted failure pressures for the various defect combinations and showed that, although interaction between the defects was predicted to occur, the effects on failure pressure were small – less than a 2% reduction over the predicted failure pressure of the single worst defect. A Von Mises stress distribution for one of the defect combinations analysed is shown in Appendix E.

The failure pressures predicted by the FEA study showed that the depth of the worst feature recorded was beyond the limit of what could be demonstrated to be acceptable with the design MAOP. The step was therefore taken to down-rate the pipeline by 20 bar from 148.9 barg to 128 barg.

Figure D1 – Von Mises Stress Distribution for Worst Defect Combination

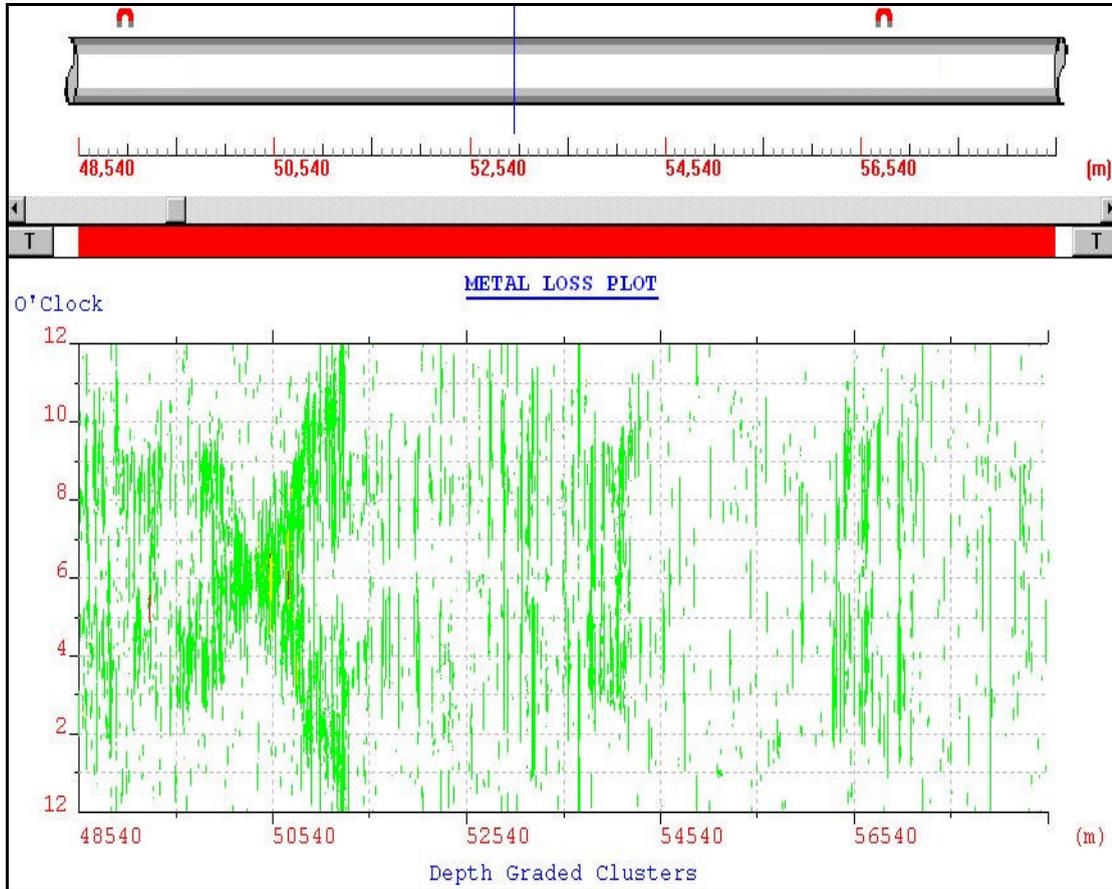
Locations for the magnets were chosen bounding the worst area of corrosion to be bypassed, also attempting not to hide significant features under the magnets themselves. The positioning of the magnets and an overall view of the reported corrosion can be seen in Appendix D. These magnets were used as reference points for the bypass tie-in, and were also used to locate the pipe joints for cutting out and recovery to the surface.

Figure E1 – General Corrosion Plot and Magnet Positions for Section of Pipeline

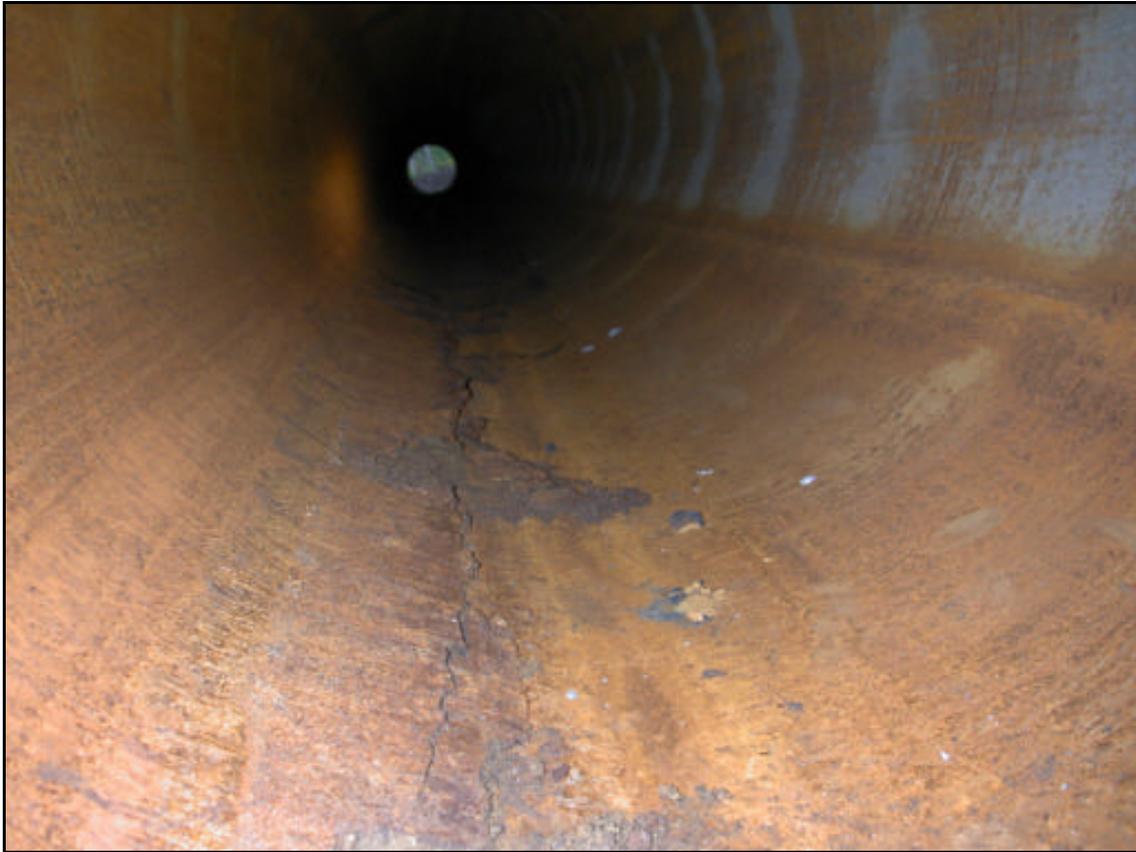
Both pipe joints were examined internally, their size allowing good access for visual inspection. The pipe joint that contained the worst “corrosion” was found not to contain any corrosion features, but instead a layer of apparently rusty material was seen to be deposited on the bottom of the pipeline centred around the 5 – 5.30 o'clock position for a length of approximately 10 m (starting and ending approximately 1 m inward of the ends of the pipe joint). Two white, calcareous deposit lines were visible around the 3 o'clock and 9 o'clock running along the length of the pipe (these were later identified as Magnesium Hydroxide). These appeared to be some form of interface mark (essentially a “tide mark”), and confirmed

The layer of rusty material formed a near-solid “sheet” varying in thickness typically around 10 mm, but up to 20 mm, and up to 220 mm wide (thinner at the upstream end than the downstream end). This “crust” was hard, brittle, and could be kicked off the pipe wall in chunks although it was surprisingly resilient to impact and abrasion. After removal from the pipe and exposure to the atmosphere for a few weeks, the crust would crumble, presumably as binding agents evaporated. No significant corrosion was evident under the debris layer. The volume of material contained in the debris crust was estimated at between 5 and 10 litres.

Figure G1 – Debris Crust in the Bottom of the Pipe

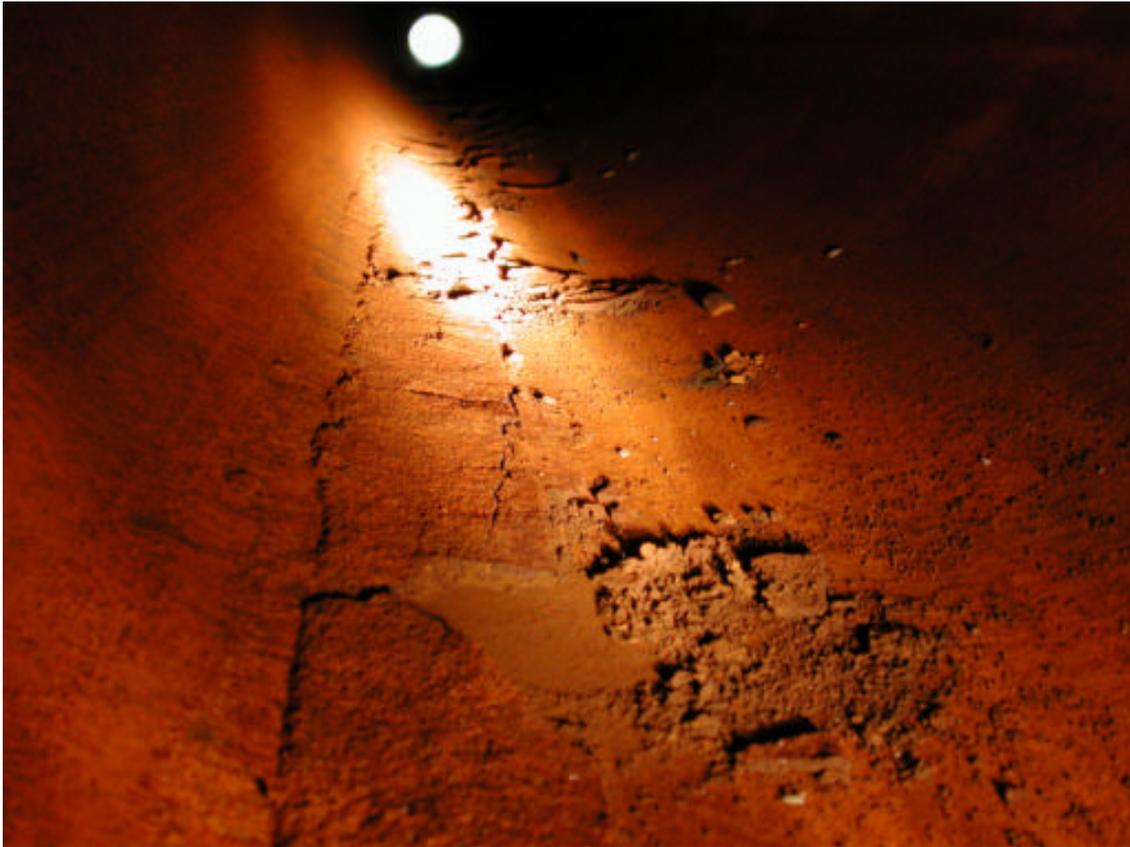
Figure G2 – Debris Crust in the Bottom of the Pipe

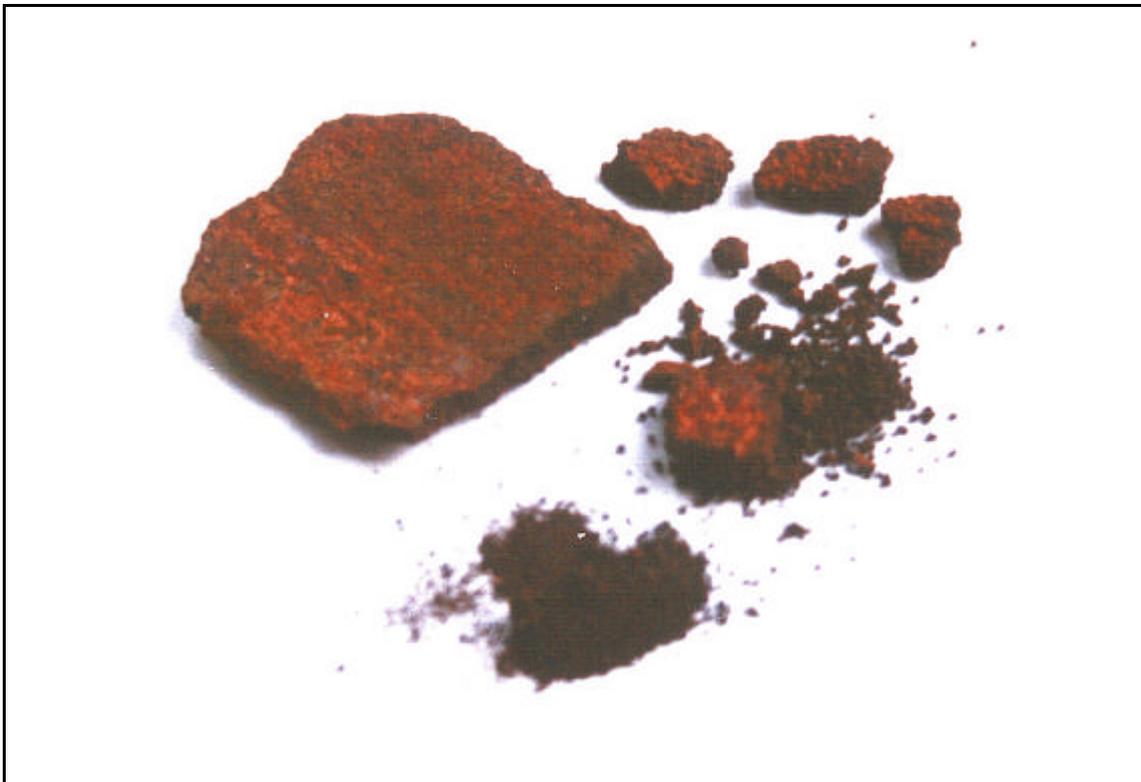
Figure G3 – Sample of Debris Crust Removed from the Pipe

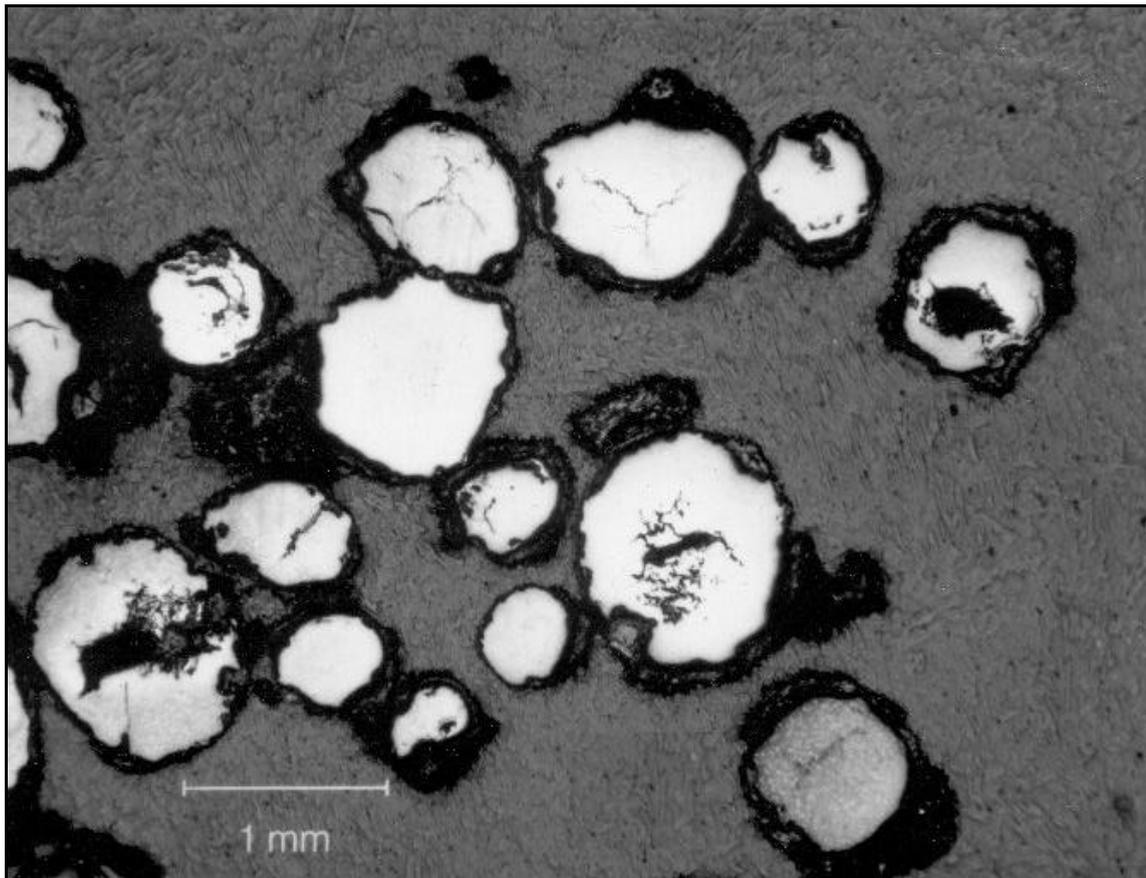
On close examination the material forming the crust was found to be made of tightly packed, tiny spherical metallic balls, typically around 1 mm in diameter, relatively consistent in size and apparently bound together by corrosion products. When sectioned and examined under a microscope, some of the spheres exhibited cracks and some were hollow. X-ray diffraction and spectroscopy analyses were performed on samples from various parts of the debris layer. The analyses identified Iron, Carbon and Silicon elements in the metallic spheres. The corrosion product was found to comprise mostly of oxides of iron. Traces of Calcium, Aluminium and Magnesium were also identified.

Figure G4 – Microscopic Close-Up of Sectioned Debris Material
