## INSPECTION & ASSESSMENT OF DAMAGED SUBSEA PIPELINES: A CASE STUDY

**Richard Espiner**  
 BP Exploration  
 Sunbury on Thames, UK

**Graham Goodfellow**  
 Penspen Integrity  
 Newcastle upon Tyne, UK

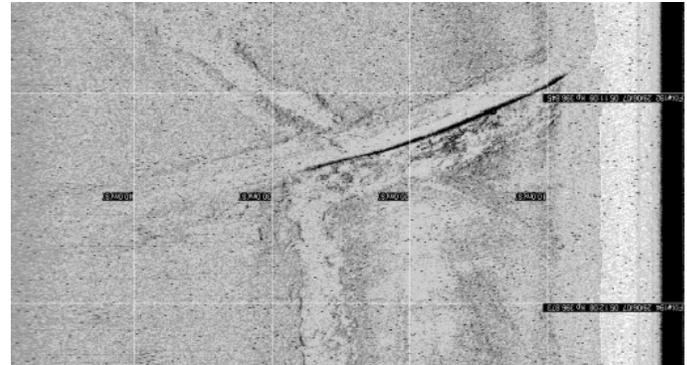
**Side Scan Sonar Image**

An Acergy survey vessel on contract to BP, the MV Polarbjorn, was diverted from its planned work to perform a survey of the pipeline using side scan sonar and a remotely operated vehicle (ROV). This survey revealed that the pipeline and its coating had been damaged by the anchor. The side scan survey identified that the pipeline had moved by a distance of approximately 4 to 5 m to the south-east. The movement had pulled the pipe through the backfill soil and caused pipeline exposure over a 94 m length. Based on disturbed seabed soil, lateral movement had occurred over a longer length of approximately 140 m. Anchor scars were clearly visible on the side scan sonar survey. The ROV video survey showed widespread damage to the concrete coating of the pipeline, see Figure 2. The pipeline concrete and underlying coal tar enamel coatings suffered extensive damage over approximately 4 m of the pipe and the pipeline steel was exposed in a number of areas.

The available video and still photography showed features that appeared to be gouges in the pipe wall, orientated in the

longitudinal direction, and a possible dent in the pipeline, see Figure 2. The pipeline was shut in and the internal pressure was reduced to 105 barg while further inspection works were planned.

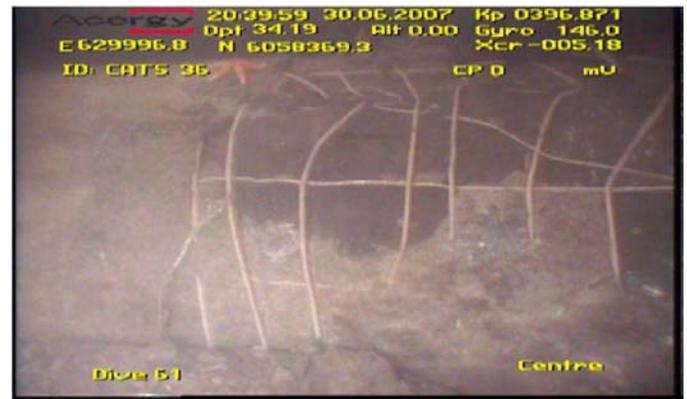
**Coating Damage**

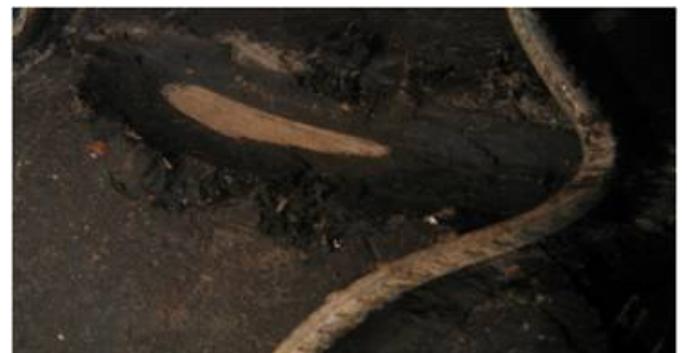
**Coating and Rebar Damage (Detail)**

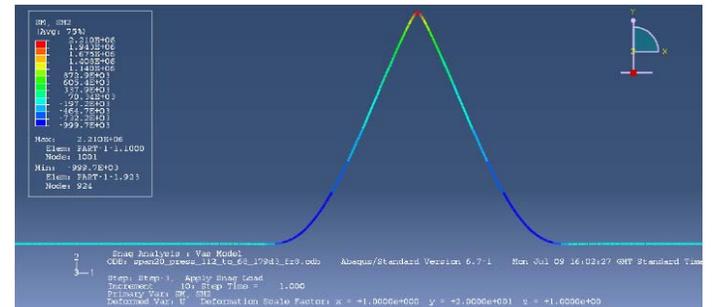
Figure 3 - Example FEA Pipe Profile

The initial inspection indicated that the pipeline had seen significant deformations during the incident. The displacement of the deformed pipeline was modelled using finite element analysis (FEA) to understand the loads applied to the pipeline and the stress state within the pipe, both during and after the incident.

The FEA required a number of unknown parameters, including the loads applied to the pipeline by the anchor and the soil restraint acting on the pipeline. The unknowns were estimated by comparing the FEA predictions of pipe position and shape following the event against the results of the initial survey. The results of the FEA (Figure 3) showed that the pipeline had been plastically deformed in the region of lateral displacement and revealed areas of high longitudinal stresses, both tensile and compressive, in some areas of the pipe. These stresses were partially “locked-in” due to the residual stress distributions arising from the permanent deformation of the

pipeline. The predicted peak stresses were tensile and close to the yield strength of the pipe material.

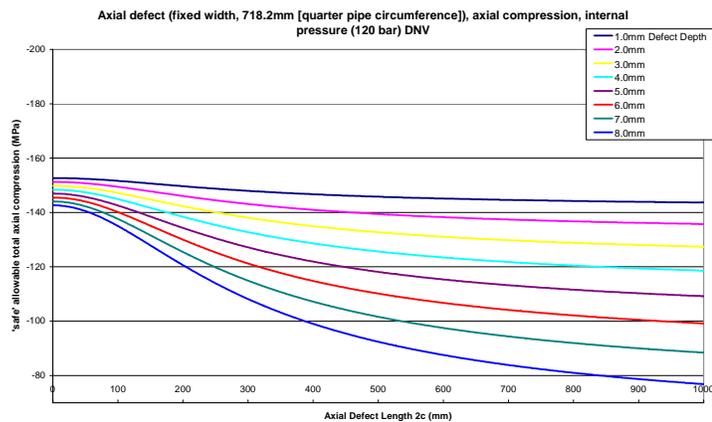
**Figure 4 - Defect Assessment under Axial Compressive Loadings**

PDAM does not contain a method for the assessment of longitudinally-oriented gouges subject to internal pressure and axial compressive loading, as there are no published methods addressing this defect and load combination. PDAM advises the user to seek specialist advice. The specialist advice provided by Penspen for the CATS assessment was to use the method recommended in PDAM for the assessment of a part wall corrosion defect subject to the same loading condition, and use the axial stress dependent term of this method to modify the

standard method for longitudinal gouges under internal pressure loading. Using this modified method, Penspen produced defect acceptance charts which demonstrated that for the areas of the pipeline that were in axial compression, the tolerable defect size was so small that in practical terms any gouges in these areas of the pipe must be repaired before the pipeline could operate at MAOP, Figure 4. A similar result was obtained for circumferential gouges in the areas of highest tensile stress. These assessments conservatively considered the locked-in stresses to be primary (externally applied) stresses; no allowance was made for any relaxation of stress due to deformation.

Any defect assessment method will produce very small defect acceptance levels at these high stresses, as the methods used are 'flow stress' dependent, i.e. they cannot accommodate stresses much beyond yield, and at stresses approaching and beyond yield they produce vanishingly small acceptable defect sizes. This does not present a significant problem for onshore pipelines because such large axial stresses are rarely present; however, for subsea pipelines there is the potential for high locked-in compressive stresses to be generated as a result of pipeline displacement. The experience of the CATS incident shows that there is a need for further research to develop defect assessment methods that take account of these loads.

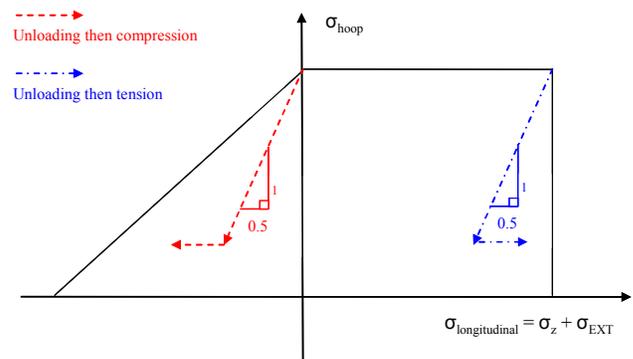
**Figure 5 - Failure Diagram**

The principle is illustrated in Figure 5 which shows the hoop and longitudinal stress path on depressurisation superimposed on the failure locus for two part wall corrosion defects. The stress paths correspond to two worst-case defects which would have been on the point of failure prior to depressurisation. The failure locus follows a "Tresca" condition, i.e. tensile hoop and axial stresses can be considered independently, while tensile hoop and compressive stresses are combined using a linear interaction model. Depressurisation reduces both hoop and axial tensile stress, and generally moves the stress state away from the failure locus. However excavation and inspection works introduce further axial stresses which may bring the stress state closer to the failure locus and may cause failure of a previously stable defect.

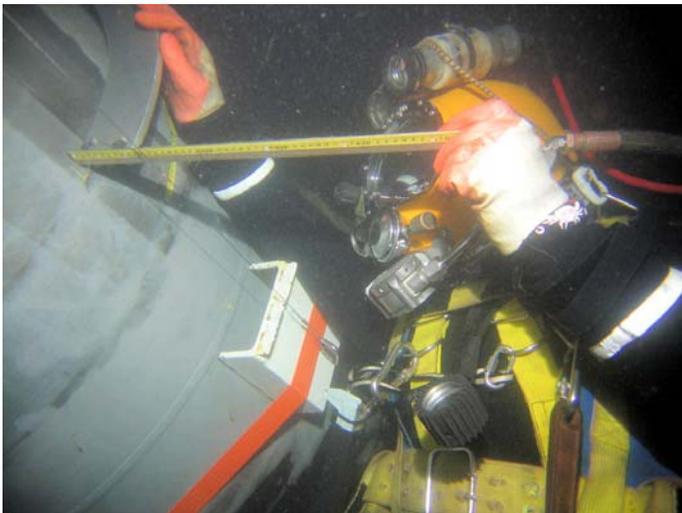
**Figure 6 - Diver Inspection (Taut-Wire)**

Following the reduction in pipeline pressure, remote jetting operations commenced from the MV Polarbjorn to excavate the damaged section of the pipeline. A more detailed visual survey was performed by ROV to assess the pipeline condition in more detail. The detailed ROV survey did not show any further damage to the pipeline or coating other than that already reported. Diving operations subsequently commenced from the Technip DSV Orelia. The operations consisted of a visual inspection of the pipe, removal of the concrete weight coating and coal tar corrosion coating from the pipeline, and a comprehensive inspection of the suspected damage, see Figures 6 & 7.

The scope of the subsequent inspection included close visual inspection of the pipeline, detailed geometrical mapping using out of straightness and ovality measurements with specially manufactured taut-wire and ovality jigs, MPI and UT inspection of all welds (including the longitudinal seam weld and circumferential welds on either side of the damaged section), full UT wall thickness survey, and measurement of any defects discovered.

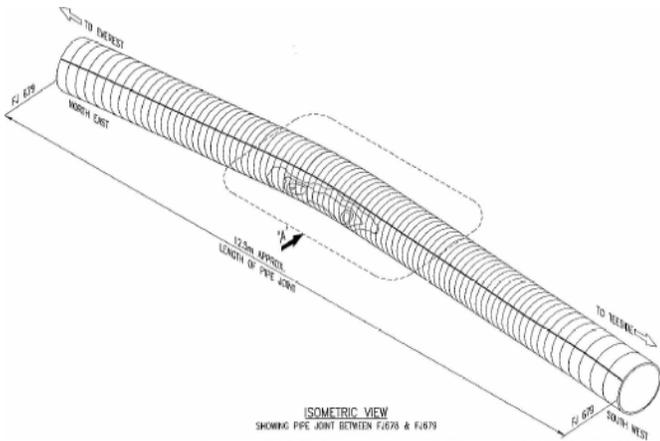
**Figure 8 - Local Deformation**

Diver access and detailed inspection on the pipe gave unexpected results. The suspected gouges in the pipe turned out to be gouges in the coal tar enamel coating only which had subsequently filled with debris from the concrete weight coating. The detailed inspection determined that there were no gouges in the pipe wall, all welds were sound and free from defects, and there were no defects or other indications of cracks in the parent pipe. The suspected dents were not confirmed and the divers initially reported no dents in the pipe. However, following removal of the concrete coating from the entire pipe joint, further diver inspection revealed a complex dented feature which was confirmed by detailed geometric mapping. The dented area was centred at about 8 o'clock (looking along the pipe away from Teesside) and extended up to the pipe seam weld at around 10 o'clock. Detailed geometric mapping of the area determined that the overall axial extent of the deformed area was approximately 4 m, Figure 8. The feature consisted of an ovalised section due to the high bending curvature at the peak of the pull over, superimposed on which were two pronounced "dents". The greatest depth of the two dents was 31 mm at the deepest point.

PDAM states that plain dents with depth less than 7% of the pipe diameter do not affect the static strength of the pipeline. The measured depth of the deepest dent in the CATS pipeline was 3.4% of diameter. Possible interaction between the two dents and the residual curvature of the pipe was assumed to have no effect on burst pressure. The assessment therefore concluded that the dent was tolerable at MAOP.

Using the PDAM recommended method, the remaining fatigue life of a 31 mm deep dent on the seam weld was calculated to be 17 years. This was considered an upper bound to the fatigue life of the reported damage, as the assessment did not take account of the complex shape of the feature, including the pipe curvature, the two dents, or the presence of a compressive axial stress. The estimated fatigue life was lower than the remaining design life of the pipeline, and therefore some form of pipeline repair or reinforcement would be required, although not necessarily immediately. A further fatigue check was then performed to assess the fatigue due to the single cycle of depressurisation from normal operating pressure down to 54 barg and back to normal operating pressure. This check was performed using the same PDAM method and indicated that a substantial proportion of the pipeline fatigue life would be consumed during this single depressurisation cycle. It was therefore decided to repair the damage prior to repressurising the pipeline.

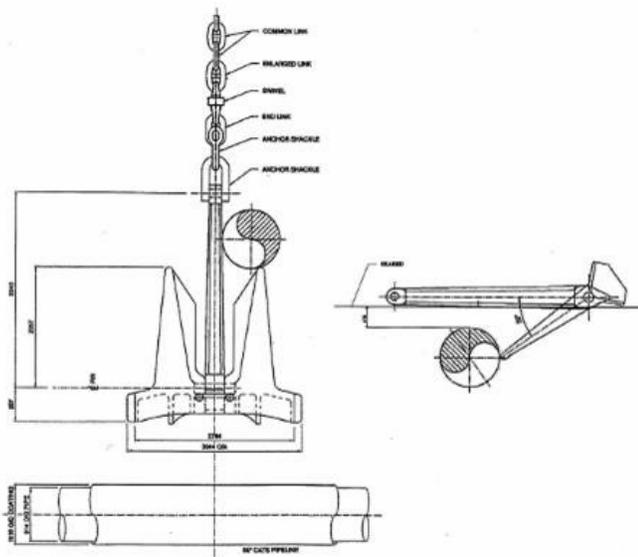
**Figure 9 - Anchor and Pipeline (to scale)**

The geometry closely matched the dimensions of the vessel anchor. The spacing of the two dents was approximately equal to the spacing of the anchor flukes while the mid-point between the two dents matched the point of maximum pipe curvature and ovality. Drawings showing the anchor and pipe supported the conclusion that the feature had been caused by the anchor hooking on the pipe and pulling it sideways, Figure 9.

Maritime data [1] indicate that the vessel crossed the CATS pipeline while drifting at a speed of around 2 knots. The kinetic energy of the anchor can be estimated from the effective mass of the anchor and was of the order of 10 kJ. In pipeline terms, the impact energy is relatively low, primarily because of the low anchor velocity. This impact energy can be absorbed by typical concrete coatings without affecting the pipe steel [3]. It is likely that the “impact” damage (i.e. at the moment of impact between anchor and pipeline) was limited to the concrete coating only. The locations of the two dents, equidistant from the point of maximum pipeline curvature, suggest that the two dents probably formed later due to the same anchor chain tension which induced the lateral movement of the pipeline. The other coating damage along approximately 4 m of pipe may have occurred as the anchor freed itself from the pipe.
