IPC02-27119

SMART PIG 'FINGERPRINT' INSPECTIONS CAN LEAD TO FITNESS FOR PURPOSE ASSESSMENTS AND CONTRACTUAL DISPUTES

Roland Palmer-Jones, Phil Hopkins

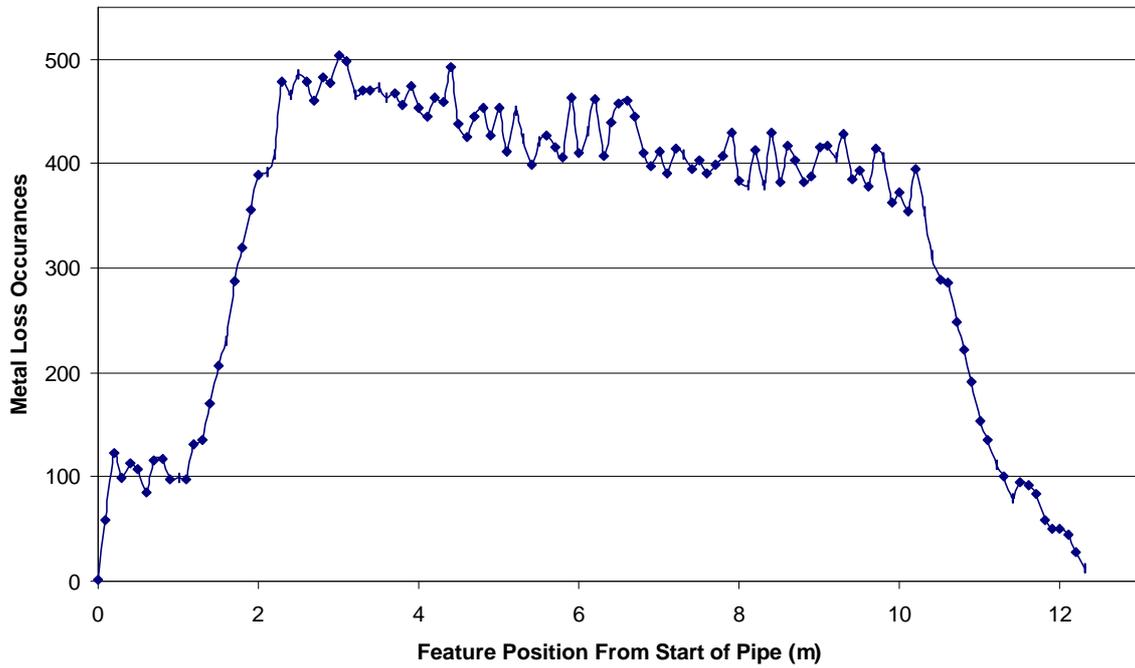
Figure 4 Position of reported features along all pipe spools

Debris (solids) is less likely to collect in the pipe ends, and the ends of the pipe will dry out quickly. This explains the corrosion pattern seen on this pipeline, where there is no corrosion within 100mm of the end of any pipe, and very little within 1m of the end of any pipe (see Figure 4 and Figure 5).

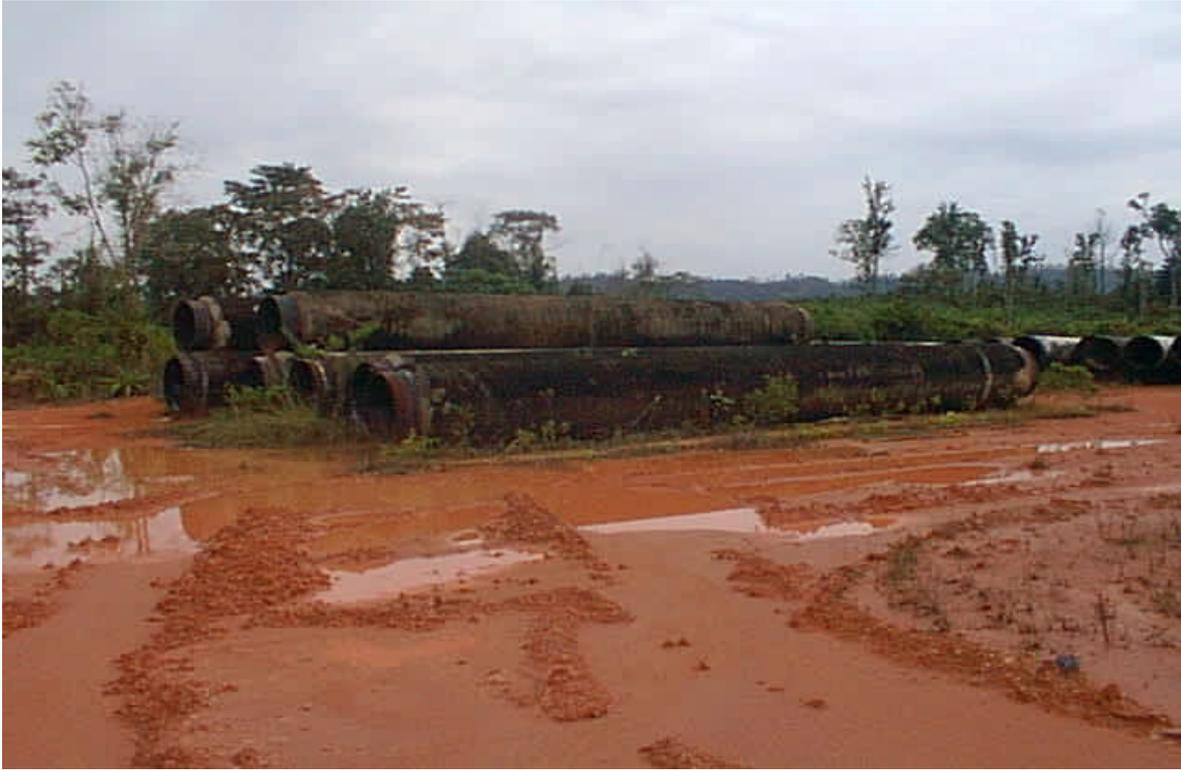
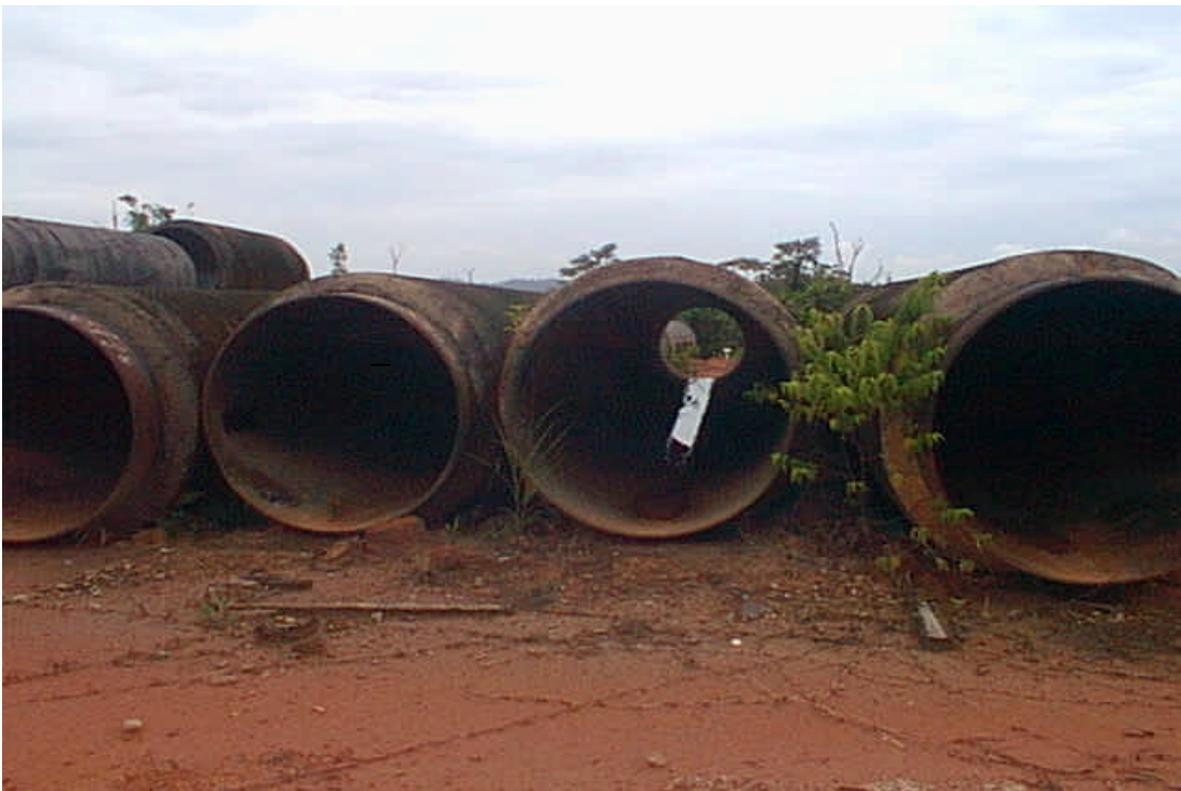
Figure 6 Spare Storage Pipes at KP 41

During a site visit in February 2001, various observations were made regarding the local environment, the potential for corrosion and the condition of some of the pipes that have remained on site since the construction of the pipeline (Figure 6).

Figure 6 illustrates the local storage environment. The absence of pipe end caps allows sand and other solids to build up in the pipe. These trap water and prevent complete drying out of the pipes after rainfall, or from condensation at night. This leads to a continuously wet bottom layer, or a wet/dry cycle. The wet/dry cycle accounts for the loose iron deposits reported by the laboratories at the sides of the solid deposits.

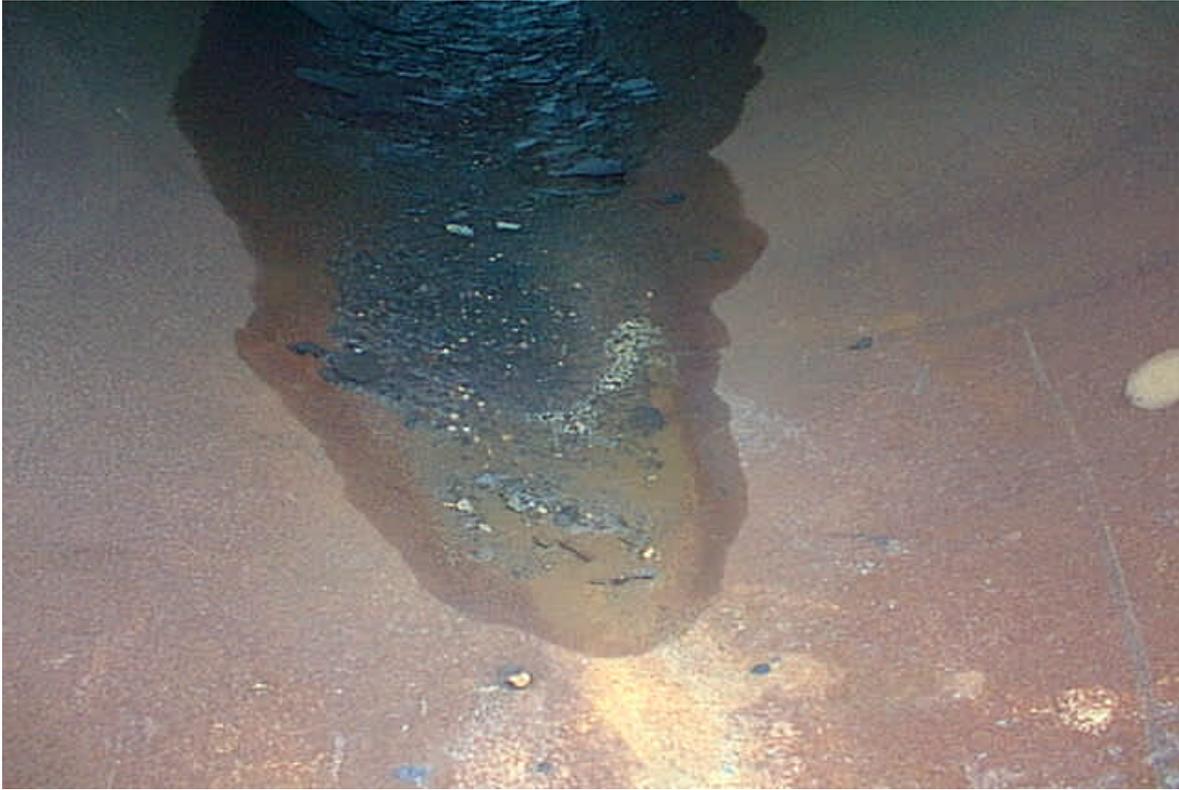
Figure 7 Illustration of Wet / Dry Corrosion Cell in a Spare Pipe

Figure 7 illustrates the wet drying process in operation. The identified corrosion products are explained and typically formed in the following manner^[5, 6].

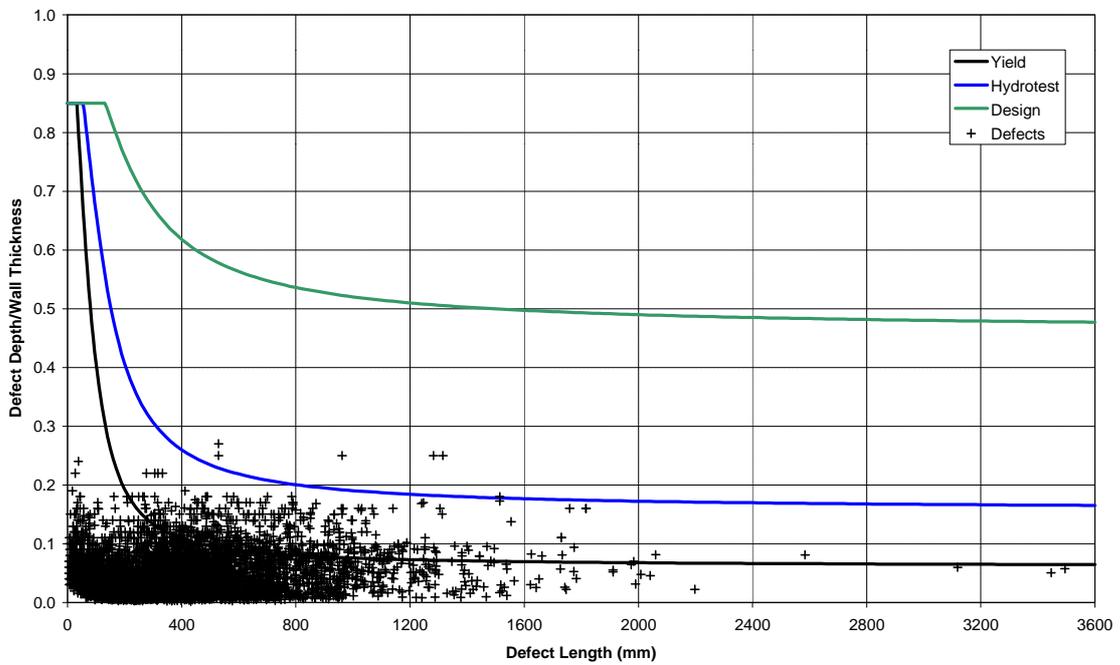
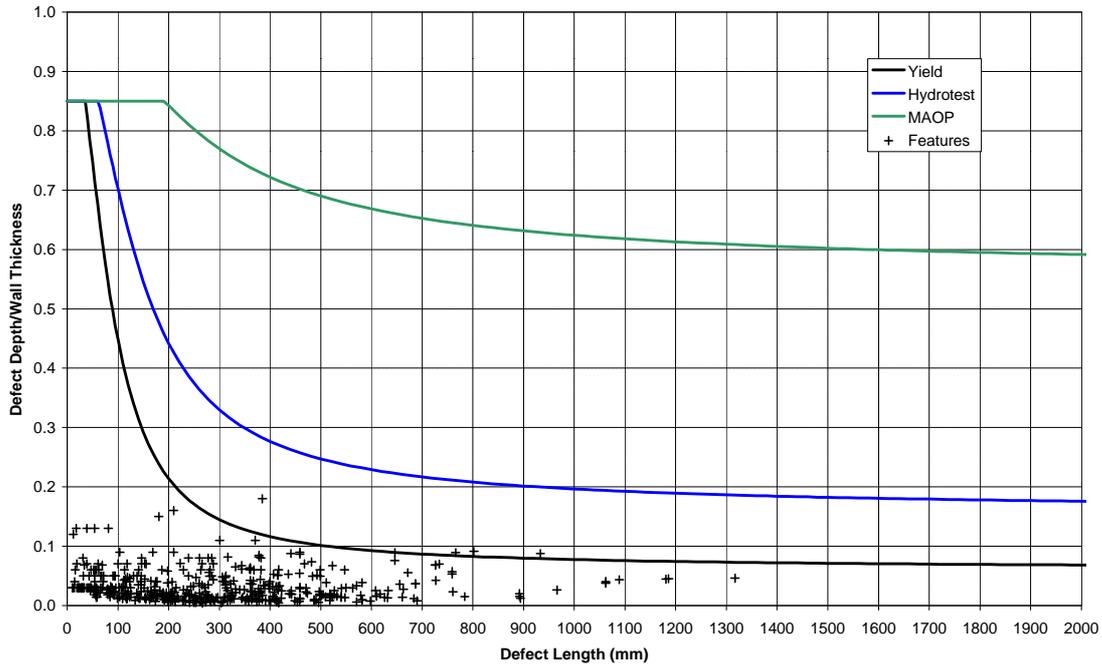
Figure 8 and Figure 9 show that DNV RP -F101 can be conservative, as it predicts failures on hydrotest, but no failures occurred.

Figure 8 Assessment of Features in 14.3mm Nominal Wall Thickness Linepipe, Using DNV RP-F101 Criteria.

Figure 9 Assessment of Features in, 17.5mm Nominal Wall Thickness, using DNV RP-F101 Criteria.

This is a significant observation, as it shows that the SWP calculated will also be conservative. The degree of conservatism is evident in Table 6 where 353 failures are predicted, but none were observed. Therefore it was concluded that the ‘marginally’ unacceptable defects need not be repaired.

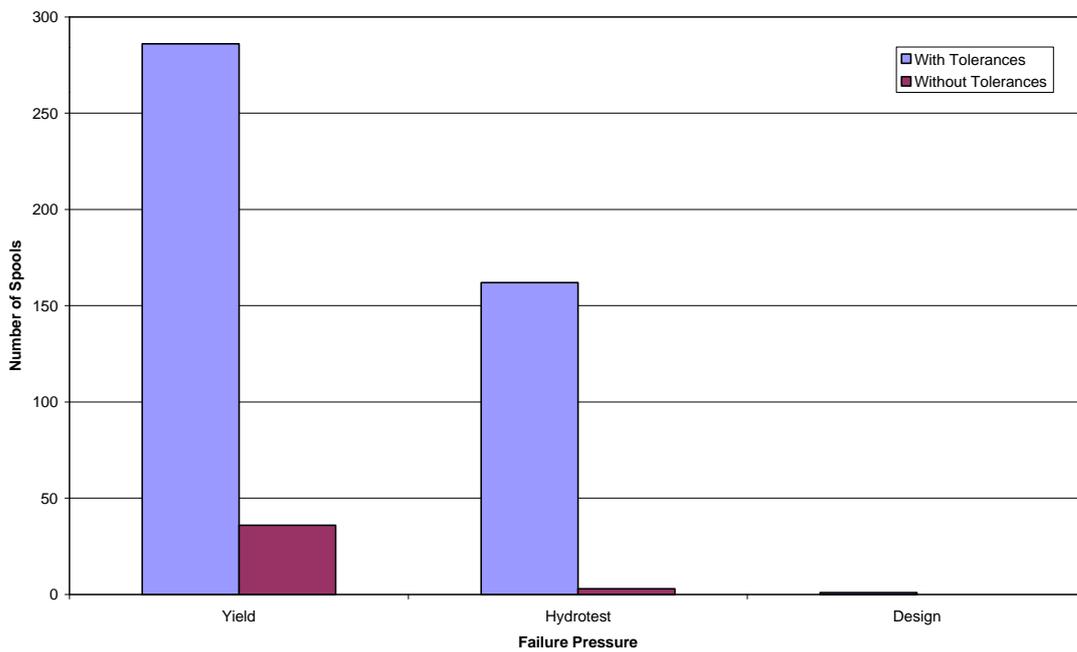
Figure 10 gives a comparison of the number of spools containing features that fail DNV RP -F101 at each specified pressure, assessed with and without inspection tolerances. It is clear that the inspection tolerances have a significant impact on the number of features and spools that are classified unacceptable. As stated in Section 5.2.1 the key evidence used in justifying carrying out the assessment without the inclusion of the inspection tolerances is the knowledge of the corrosion mechanism, and the comparison of smart pig reported values with directly measured values.

Figure 10 A comparison of the number of spools containing defects that fail DNV RP -F101 with and without inspection tolerances added.

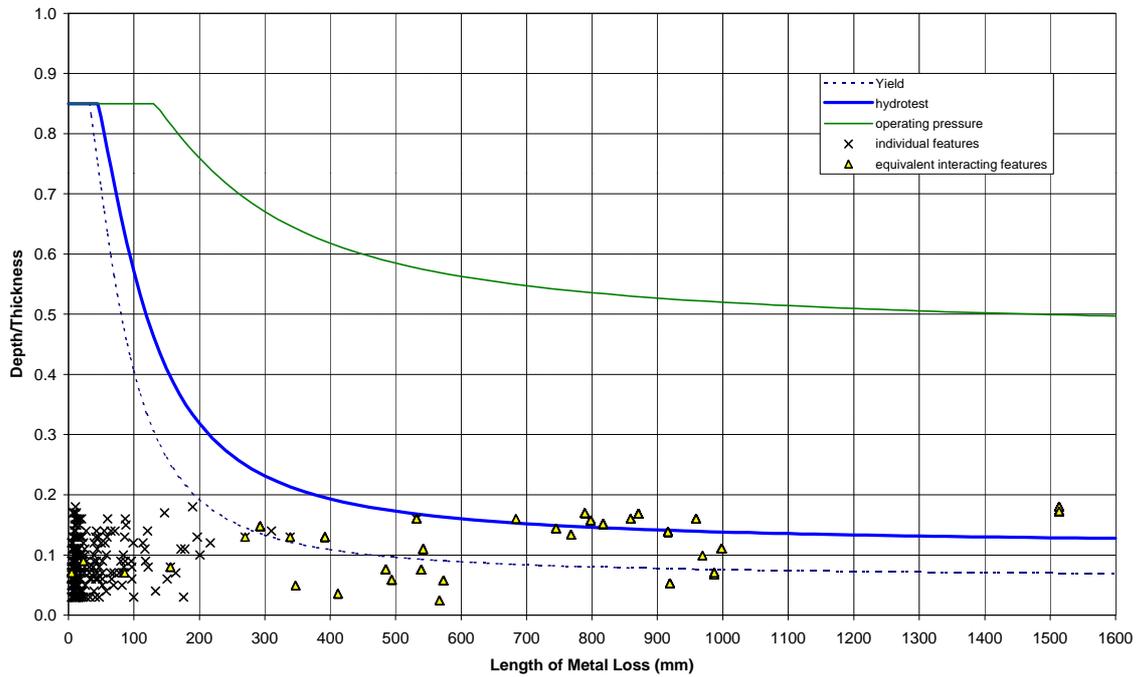
Figure 11 Sentencing plot of defects on spool 26380, Safe Working Pressure 62 bar

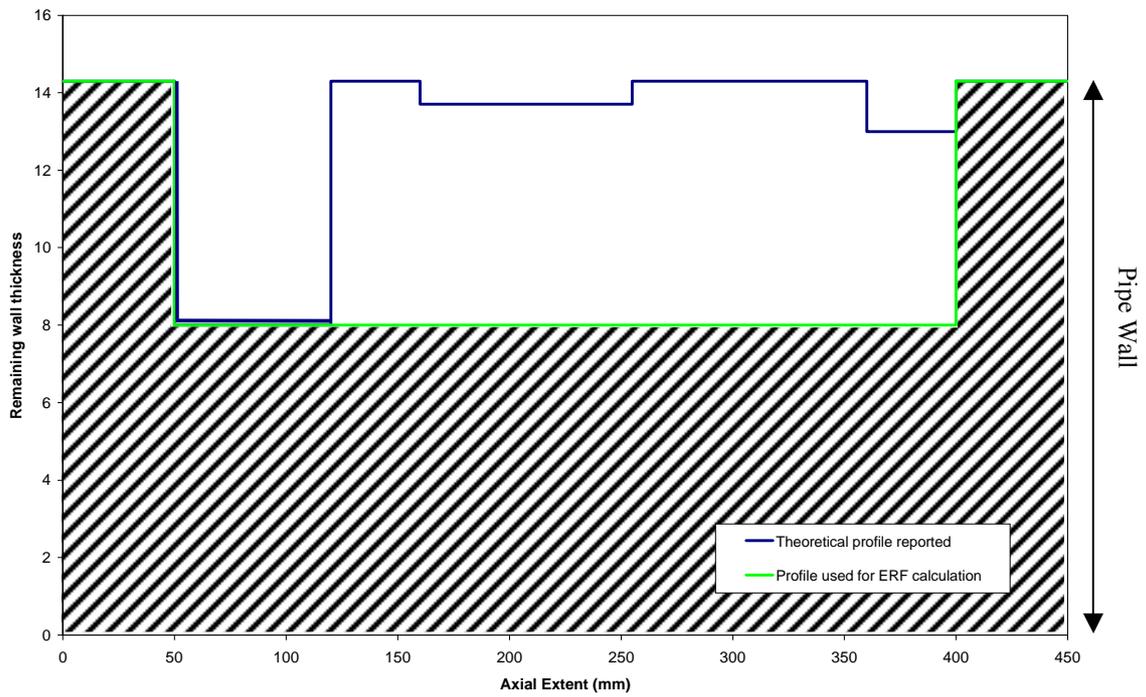
Well it is, but only if it is used carefully. For example problems can arise when defects are grouped together or ‘clustered’. Clustering is a method some smart pig inspection contractors use for simplifying the inspection data. Individual defects are recorded as ‘boxes’, with the box length, width and depth equal to the maximum length, width and depth of the defect. For defects that are close together, the boxes that define that defect are ‘clustered’ together according to defect interaction rules. Consequently, they are treated as a single defect with the length equal to the distance from the start of the first ‘box’ to the end of the last ‘box’, and the depth is equal to the depth of the deepest ‘box’ within the cluster (Figure 12). This method is well proven; however in the past only defects that were deeper than 10% or 20% of the wall thickness would have been reported and then clustered. Now very shallow defects are also being included. This can lead to extremely conservative defect sizing. A theoretical example is shown in Figure 13.

Figure 13 Theoretical profile of a defect cluster, with profile used in assessing ERF value.
