The Bean: Atmospheric Corrosion of the Cloud Gate Structure

Gustavo Romero, Director of Operations, Latin America

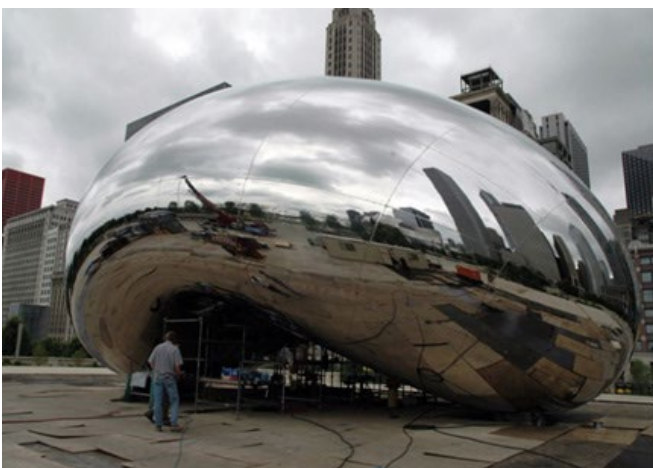
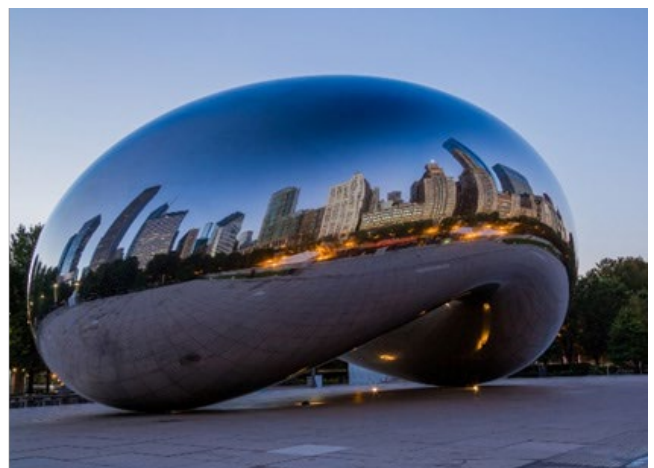
2. Structure views before and after polishing (left)

Substructure - The first indication was to build a substructure to support the shell/skin made of stainless-steel plates, so the construction, installation, and assembly of a 30,000 lb. zinc-rich steel substructure began. One of the challenges was how to support this wobbly structure to keep it upright during the construction and assembly process. Complex anchoring systems were used, including mechanical pre-tensioning systems and some chemical anchors that allowed to fix the structure to the concrete and thus continue with the fabrication process. This substructure included two large fabricated 304 stainless steel O-rings, one at the north end of this structure and one at the south end. The rings are held together with cross-linked tube armatures.

The auxiliary ring-core frame is constructed in sections and bolted on-site with reinforcements welded using GMAW and electrode welding.

Due to a delay in the assembly of the structure, it was exhibited temporarily unpolished and therefore unfinished on 15 July 2004. The seams between the sections of the shiny metal skin were not sealed or polished, making them visible. The work remained exposed for several months, until the tent surrounding it was set up again in January 2005 to allow the workers to grind, sand and polish the seams, giving the sculpture its mirror-finished appearance.

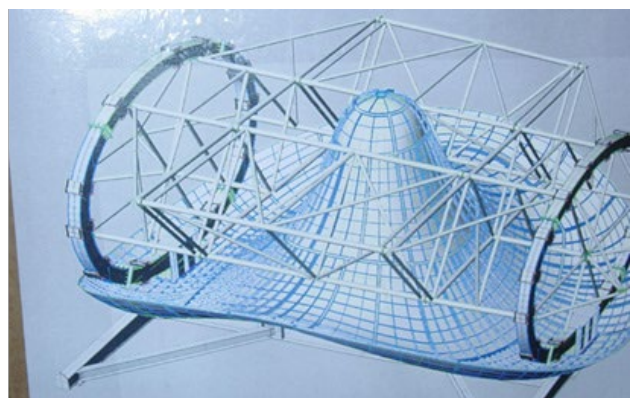
3. Image examples illustrating the computational modelling process (right)

The Bean was designed using computer modelling based on the Non-Uniform Rational B-Spline (NURBS), which represents a mathematical formula (Euler's equation) that employs the geometry of curves, circles, arcs, and surfaces in space 3. Freeform surfaces and curves can be created and edited with a high level of flexibility and precision.
