IPC02-27119

SMART PIG 'FINGERPRINT' INSPECTIONS CAN LEAD TO FITNESS FOR PURPOSE ASSESSMENTS AND CONTRACTUAL DISPUTES

Roland Palmer-Jones, Phil Hopkins

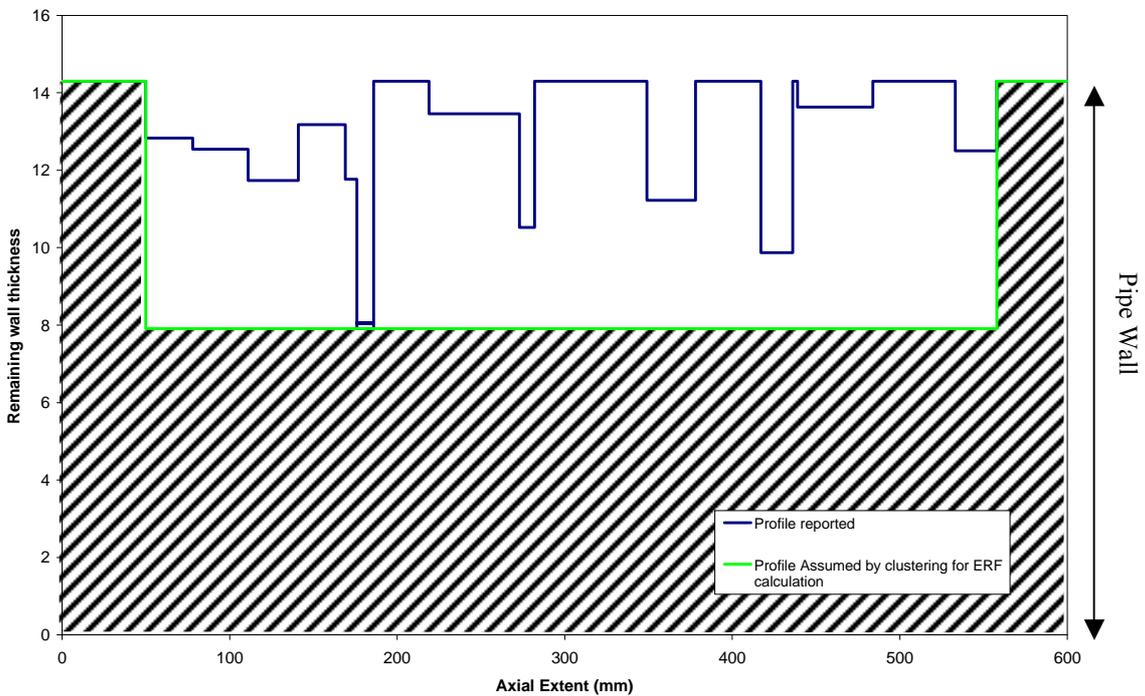
Figure 12 Reported profile of a defect cluster, with profile used in assessing ERF value.

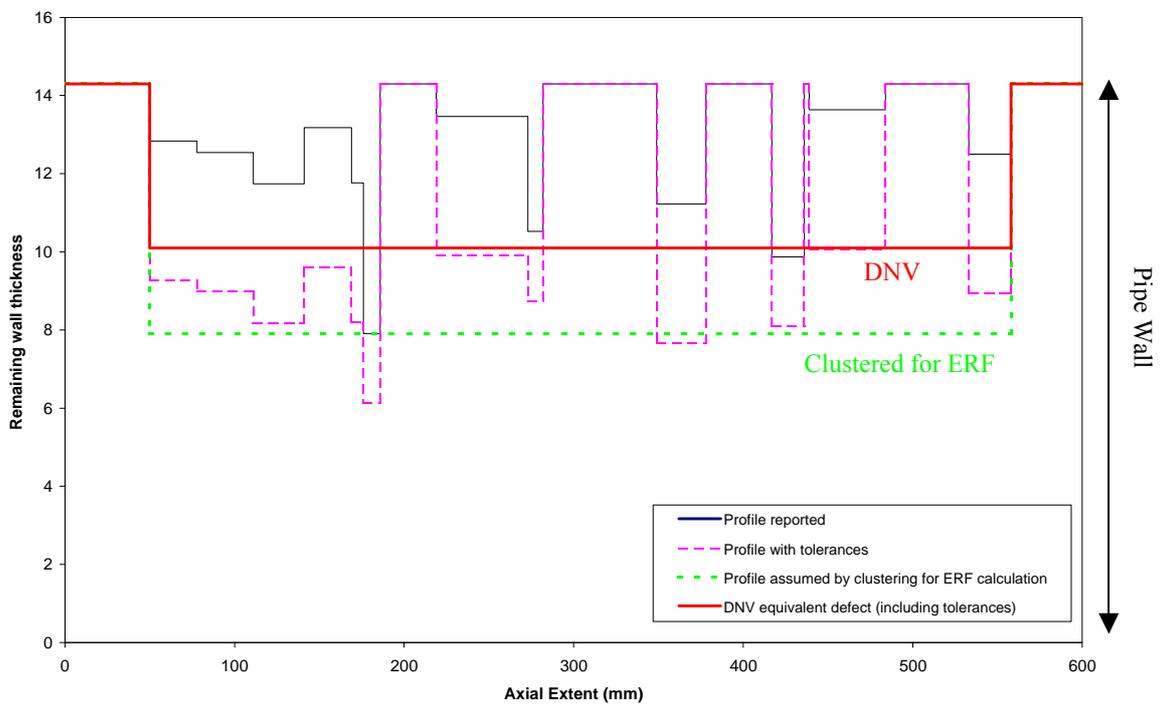
Using simple grouping and assessment tools on detailed defect data may result in a very conservative assessment, and lead to unnecessary repairs or reductions in operating pressure. To avoid this, and obtain the best value from an inspection, an appropriate level of assessment should be carried out. If detailed data is collected (usually at great expense) then it makes sense to look closely at it and analyse it carefully. This is demonstrated in Figure 14 where the equivalent defect size based on the DNV RP -F101 is overlaid on the cluster profile and the defect shape used for calculating the ERF value. The DNV equivalent defect size includes the quoted inspection tolerances, but is still significantly smaller than the clustered defect shape used for calculating the ERF value.

Figure 14 Comparison of DNV equivalent defect and defect used for ERF calculation.
