THE DEVELOPMENT OF AN EMERGENCY REPAIR SYSTEM, AND A CASE STUDY FOR A REMOTE GAS PIPELINE

Roland Palmer-Jones
Penspen Limited
Newcastle upon Tyne, UK.

ABSTRACT

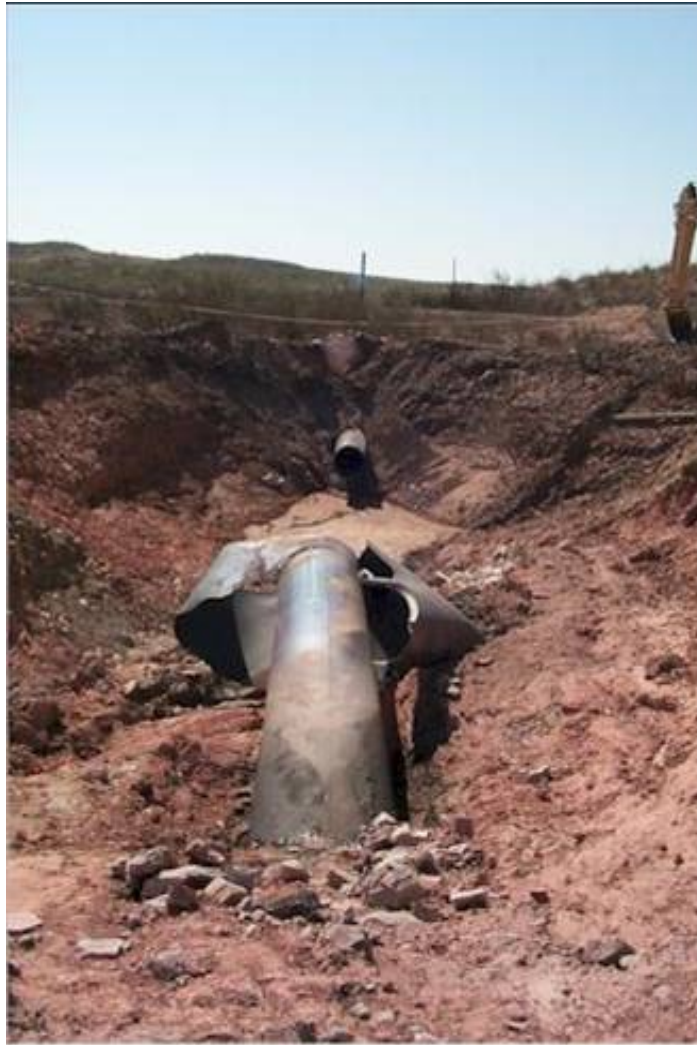
Figure 2 Rupture Site^[1]

rupture or a landslide. **Figure 2** shows a typical gas pipeline rupture site^[5].

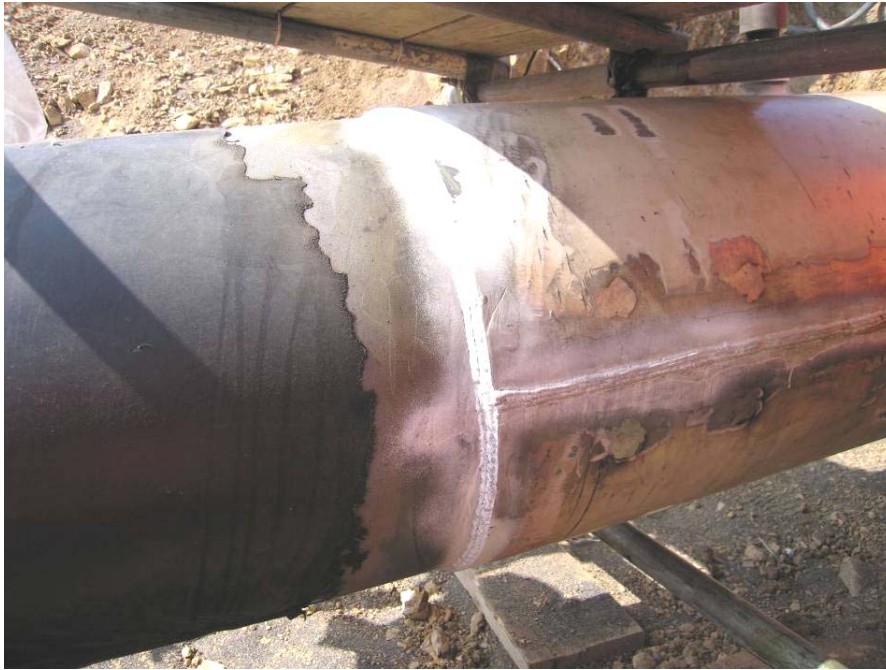
Figure 4 Close Fitting (Type B) Welded Sleeve

The type B sleeve is installed by clamping 2 half shells tightly to the pipeline, welding them together and then fillet welding the sleeve to the pipeline. Consequently it is suitable for damage such as internal corrosion that may become a leak, or damage that is already leaking. An example of a close-fitting pressure-containing sleeve is shown in **Figure 4**.

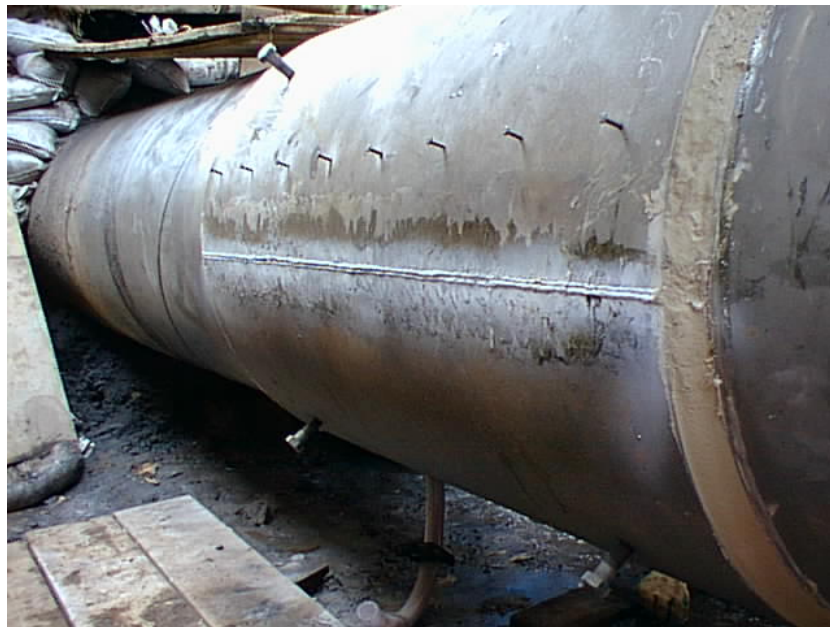
Figure 5 Epoxy Grout Filled Sleeve

The epoxy grout filled sleeve is installed by loosely assembling 2 half shells around the pipeline, with an annular gap of up to 40 mm, and welding them together. The annulus is then filled with an epoxy based grout with a very high compressive strength. The primary advantages of the epoxy grout filled sleeve are that it is not welded to the pipeline, and it is relatively easy to fit if the pipeline surface is uneven or if there is some deformation. An example of an epoxy grout filled sleeve is shown in **Figure 5**.

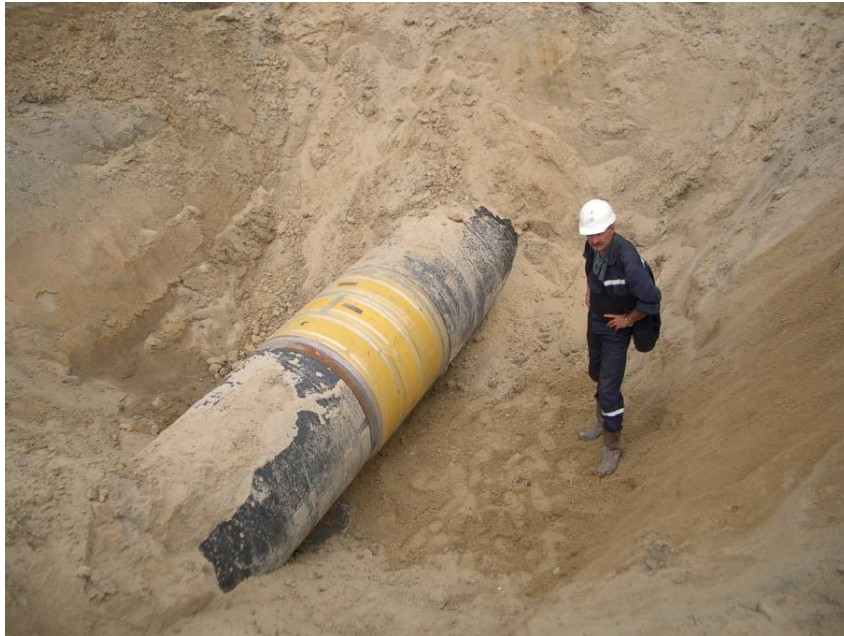
Figure 6 Composite Wrap Repair

The main advantages of composite wraps for emergency repair are the speed of installation, and the limited working space required, which reduces the time required to excavate the damage site. An example of a composite wrap repair is shown in **Figure 6**.

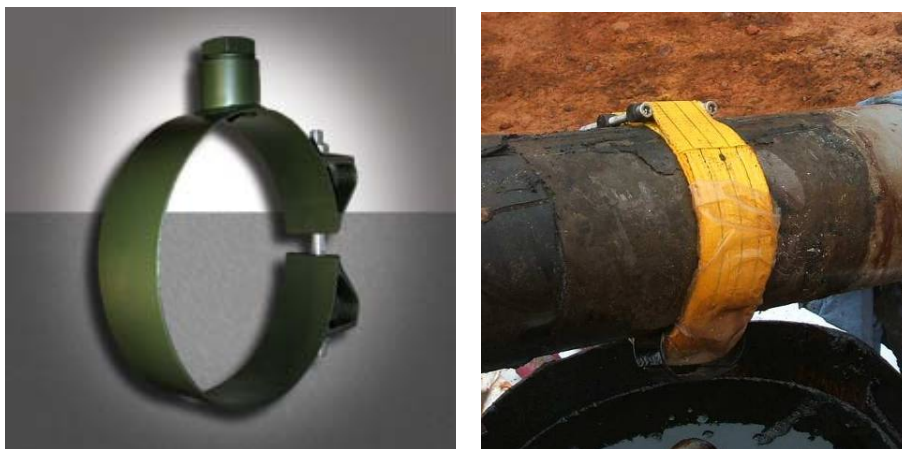
Figure 7 Pin Hole Leak Clamps (www.statsgroup.com), (www.3xengineering.com).

Pin hole leak clamps are relatively light weight and easy to mobilise, and only require a relatively small excavation. Two examples of a pin hole leak clamp are shown in **Figure 7**.

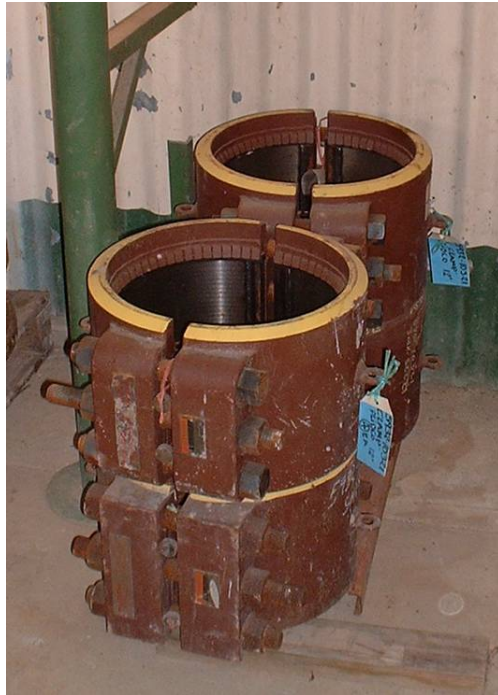
Figure 8 Bolted Clamp Repairs

An example of a bolted leak clamp repair is shown in **Figure 8**.

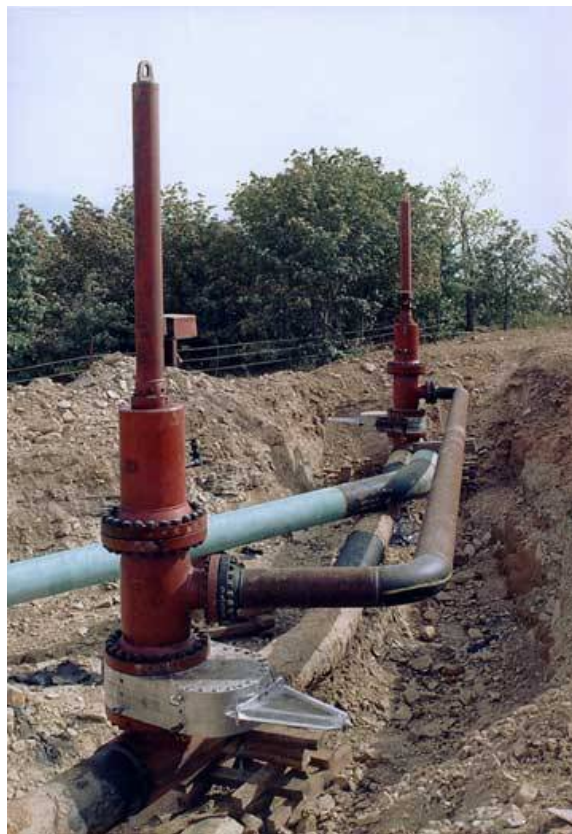
Figure 9 Stopple and Bypass (www.tdwilliamson.com)

A temporary bypass may be installed while the pipeline is operating to allow a damaged section to be removed. Alternatively a temporary bypass could be installed after a major incident to allow service to be resumed as quickly as possible and to give time for a permanent repair to be completed (Figure 9, and Figure 10).

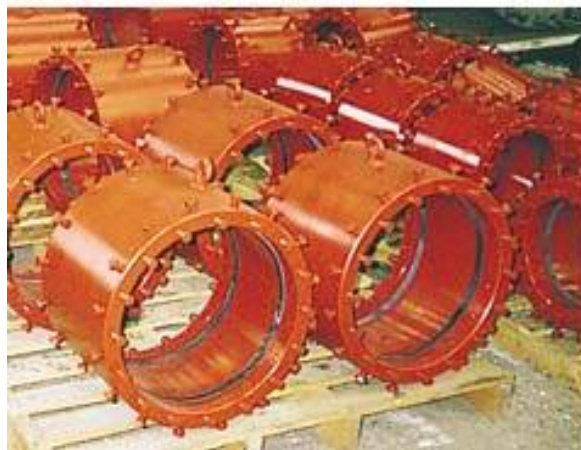
Figure 12 Pipe Connector/Coupling (www.furmanite.com)

A temporary bypass will require tees to be fitted to the pipeline and bypass pipe work to be assembled. For rapid installation mechanical connectors or couplings (Figure 11, and Figure 12) can be used to connect the main pipe sections together. A selection of flanged pieces can be used to create the connections to the main line at each end of the bypass. In addition to the bypass, isolation will be required. This is most likely to take the form of a plug inserted into the pipeline (Figure 13), but isolation pigs could be used (Figure 14).

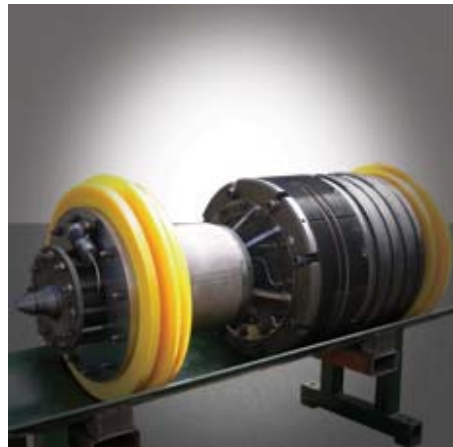
Figure 14 Remote Setting Isolation Pig (www.statsgroup.com)

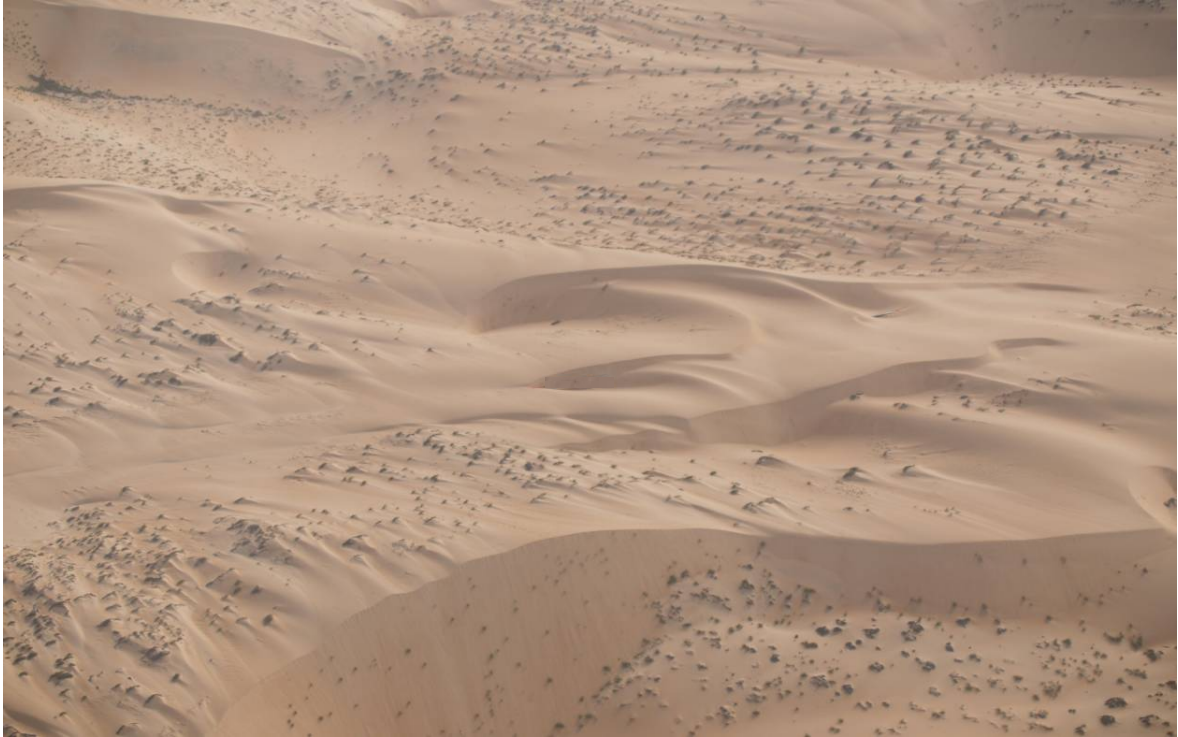
Figure 15 Desert Terrain

Another key issue is the terrain crossed by the main pipeline. In the sand dune areas vehicle access can be difficult (see **Figure 15**), and specialist vehicles are needed. In the mountainous areas there are some very steep slopes (see **Figure 16**), which will make any repair work difficult.

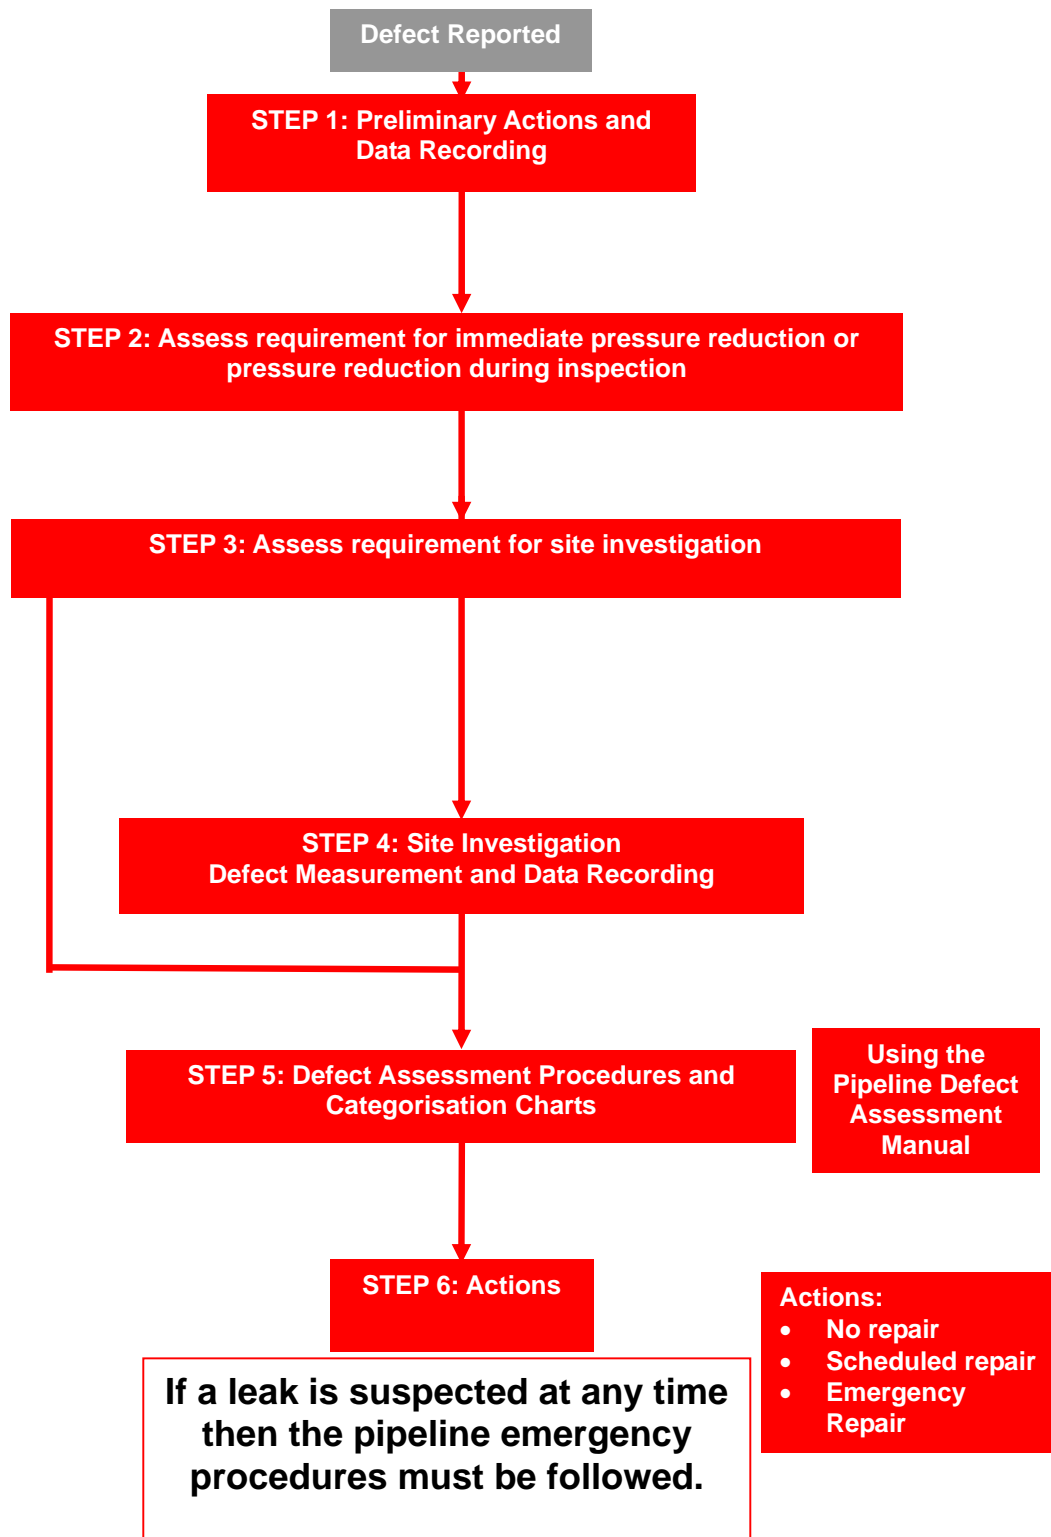
Figure 17 Summary of a Pipeline Defect Classification Procedure
