CATS Anchor Damage Assessment

The CATS natural gas pipeline is a 412 km 36" diameter subsea gas pipeline with a maximum operating pressure of 176 barg, and providing approximately 1 bcf per day of gas into the UK gas network (approximately 8% of UK supply).

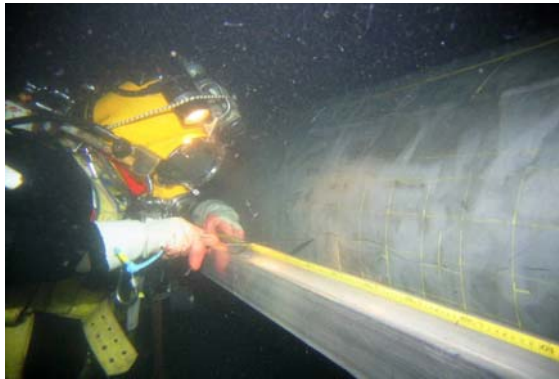
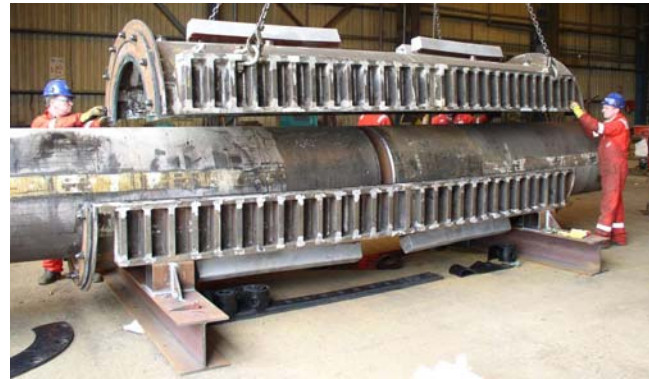
In June 2007 the anchor of a large oil tanker snagged the buried pipeline, displacing it several meters, damaging the concrete coating and denting the pipe surface. Penspen was appointed to assist BP with assessing the severity of the damage caused and advising on safe pressures, inspection, and repair.

- Evaluate damage scenarios based on preliminary reports
 - Dent analysis
 - Bending analysis
 - Dent gouge assessment
 - Combined pressure and bending loading
- On ship assurance that all possible data was collected by ROV
- Confirm safe pressure for diver inspection
- Analysis of condition for inspection
 - Span analysis
 - Stability analysis
- Define diver inspection scope
- Analysis of damage following diver inspection
 - Fatigue assessment
 - Stability analysis
- Definition of repair requirement
- Conceptual repair definition
